New Cars, Old Patients: New Insights into Crash Biomechanics

**“Innovations in Emergency Care”
William Beaumont Hospital
March 12, 2018**

**Joel B. MacWilliams, B.A.
International Center for Automotive Medicine
University of Michigan**

Subtitle
**What 38 Years of Crash
Investigation Has Taught Me**

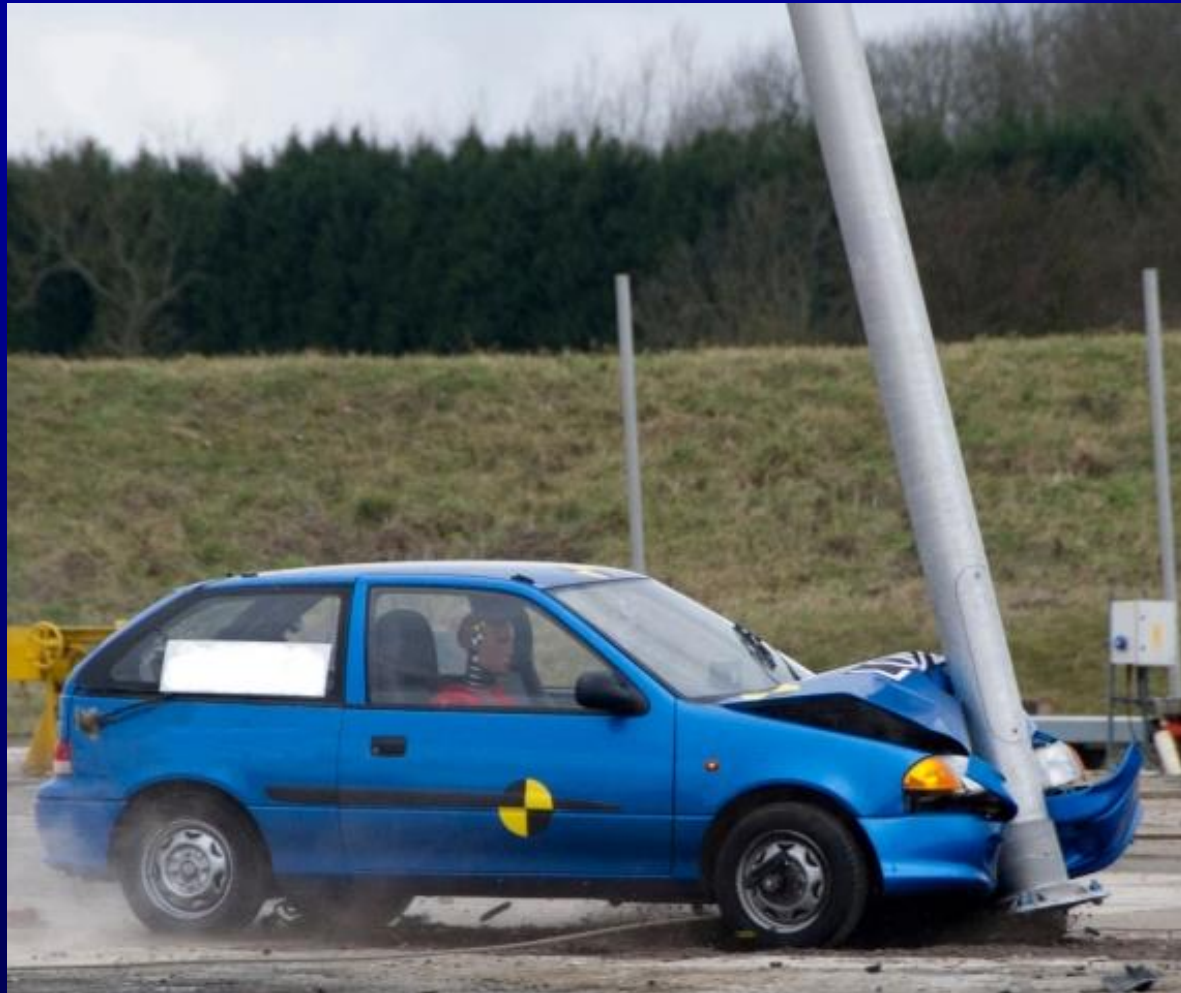
Breakaway vs. Non-Breakaway Poles

Breakaway poles dissipate energy so that the vehicle (& occupants) don't experience the full energy load of a crash

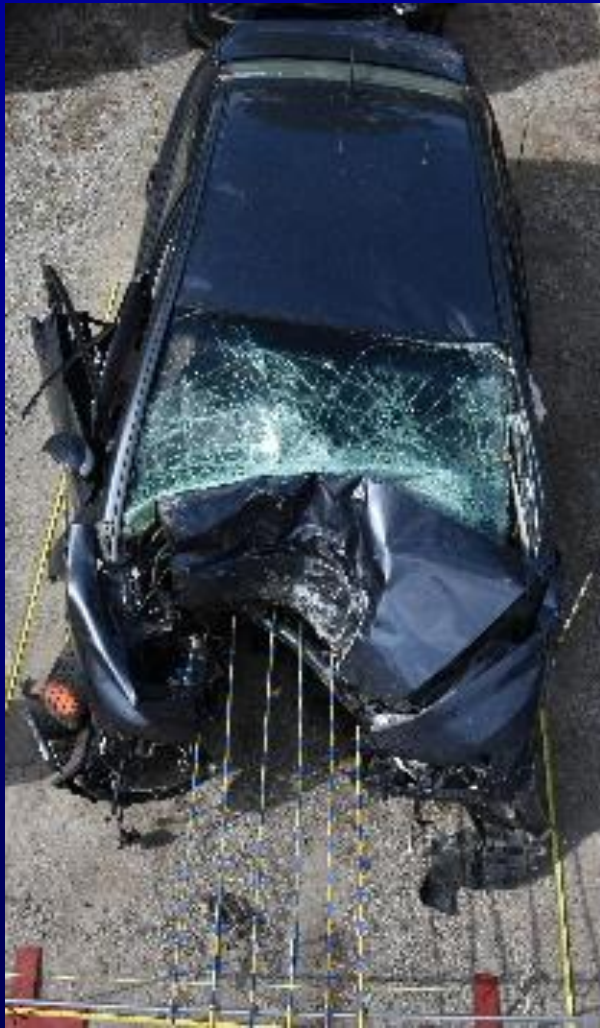
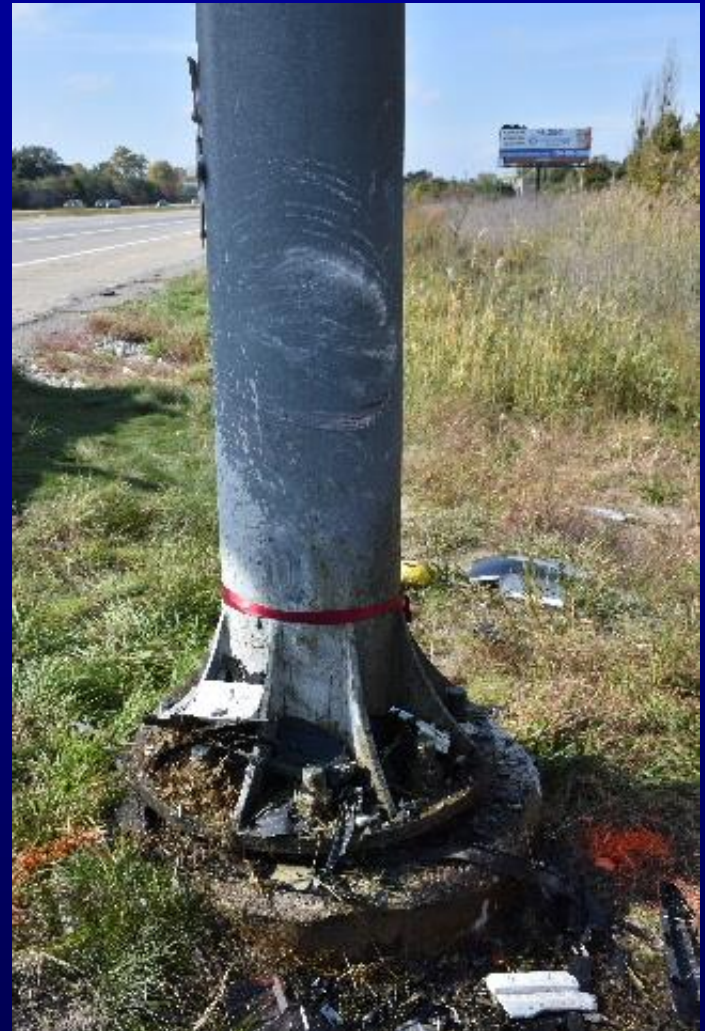
Breakaway vs. Non-Breakaway Poles

Non-breakaway pole impacts result in vehicle (and occupants) experiencing the full energy load of the crash

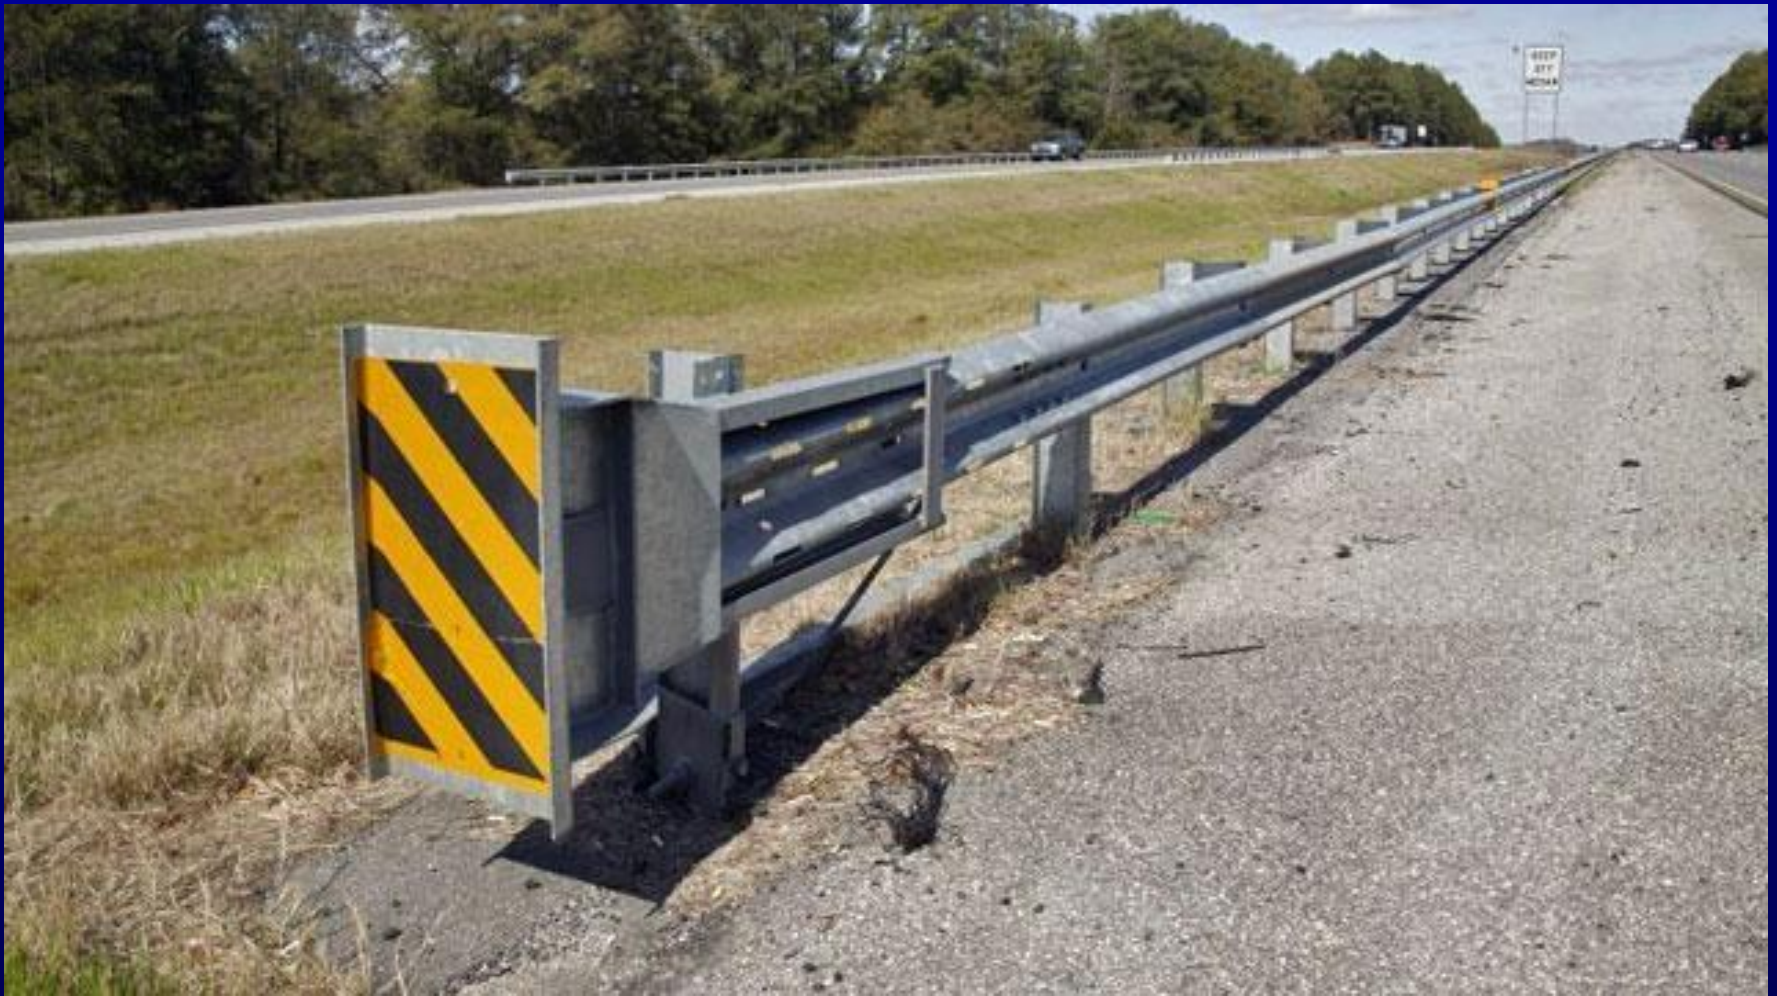
Guardrail End Treatments

Energy absorbing guardrail end treatment

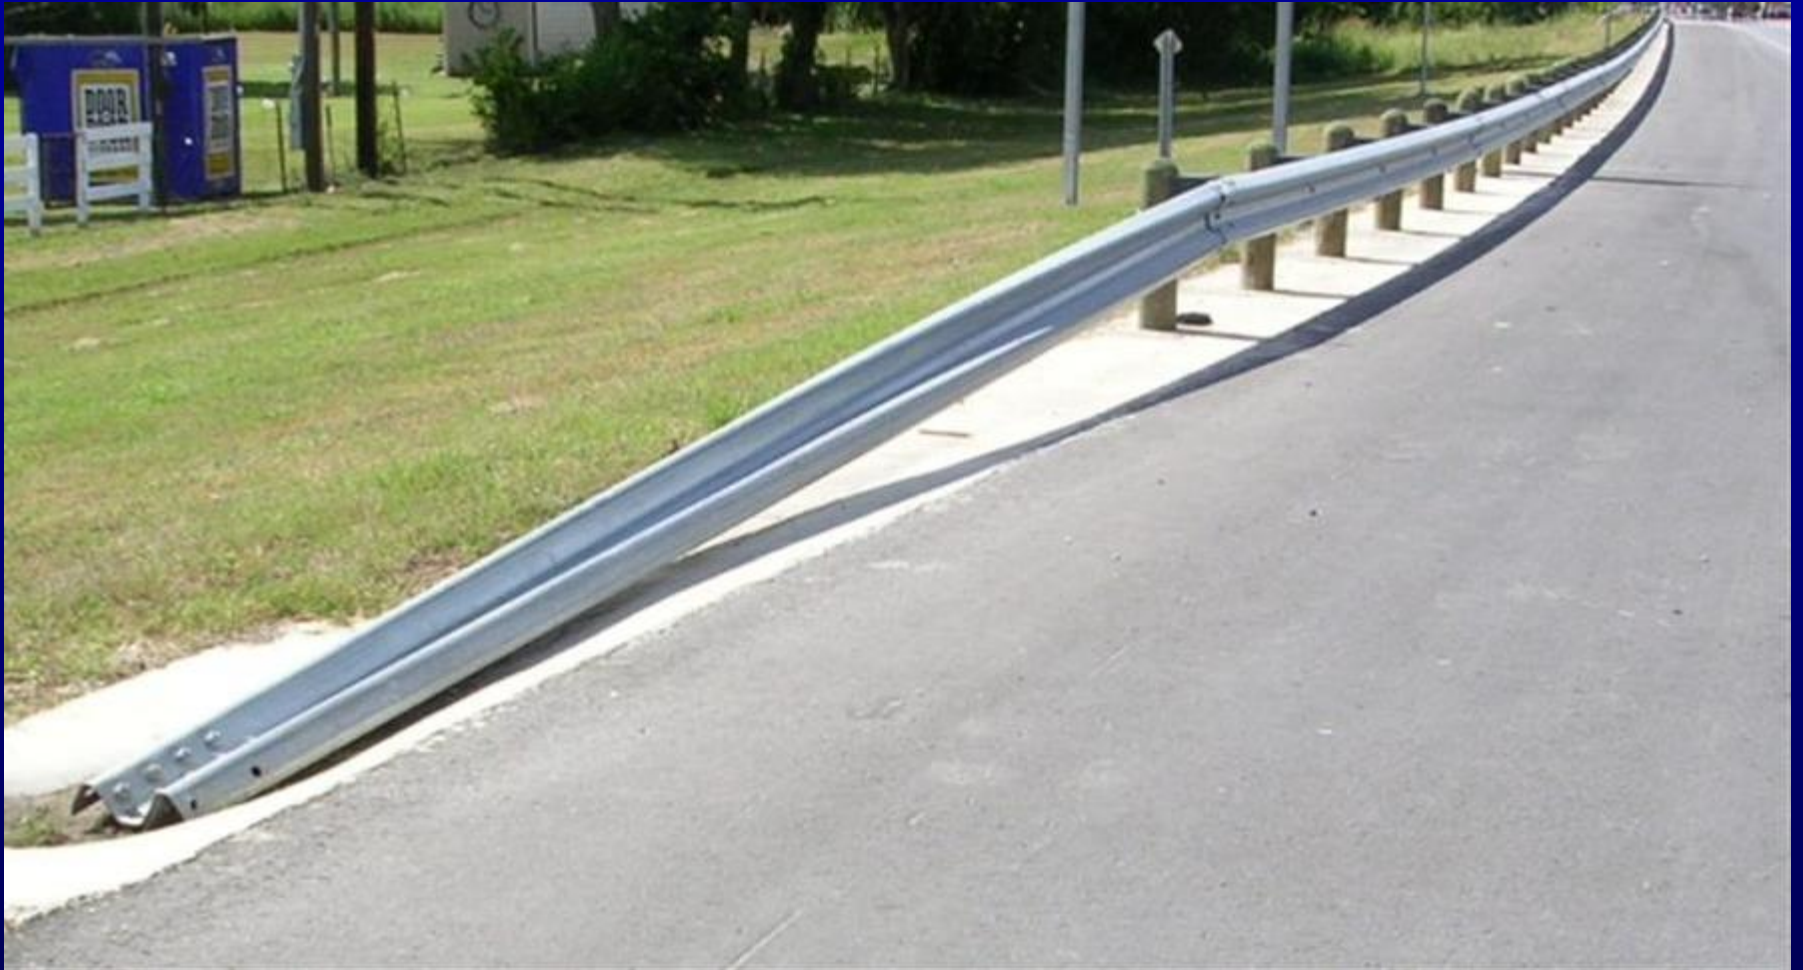
Guardrail End Treatments

“Turned Down” guardrail end treatment

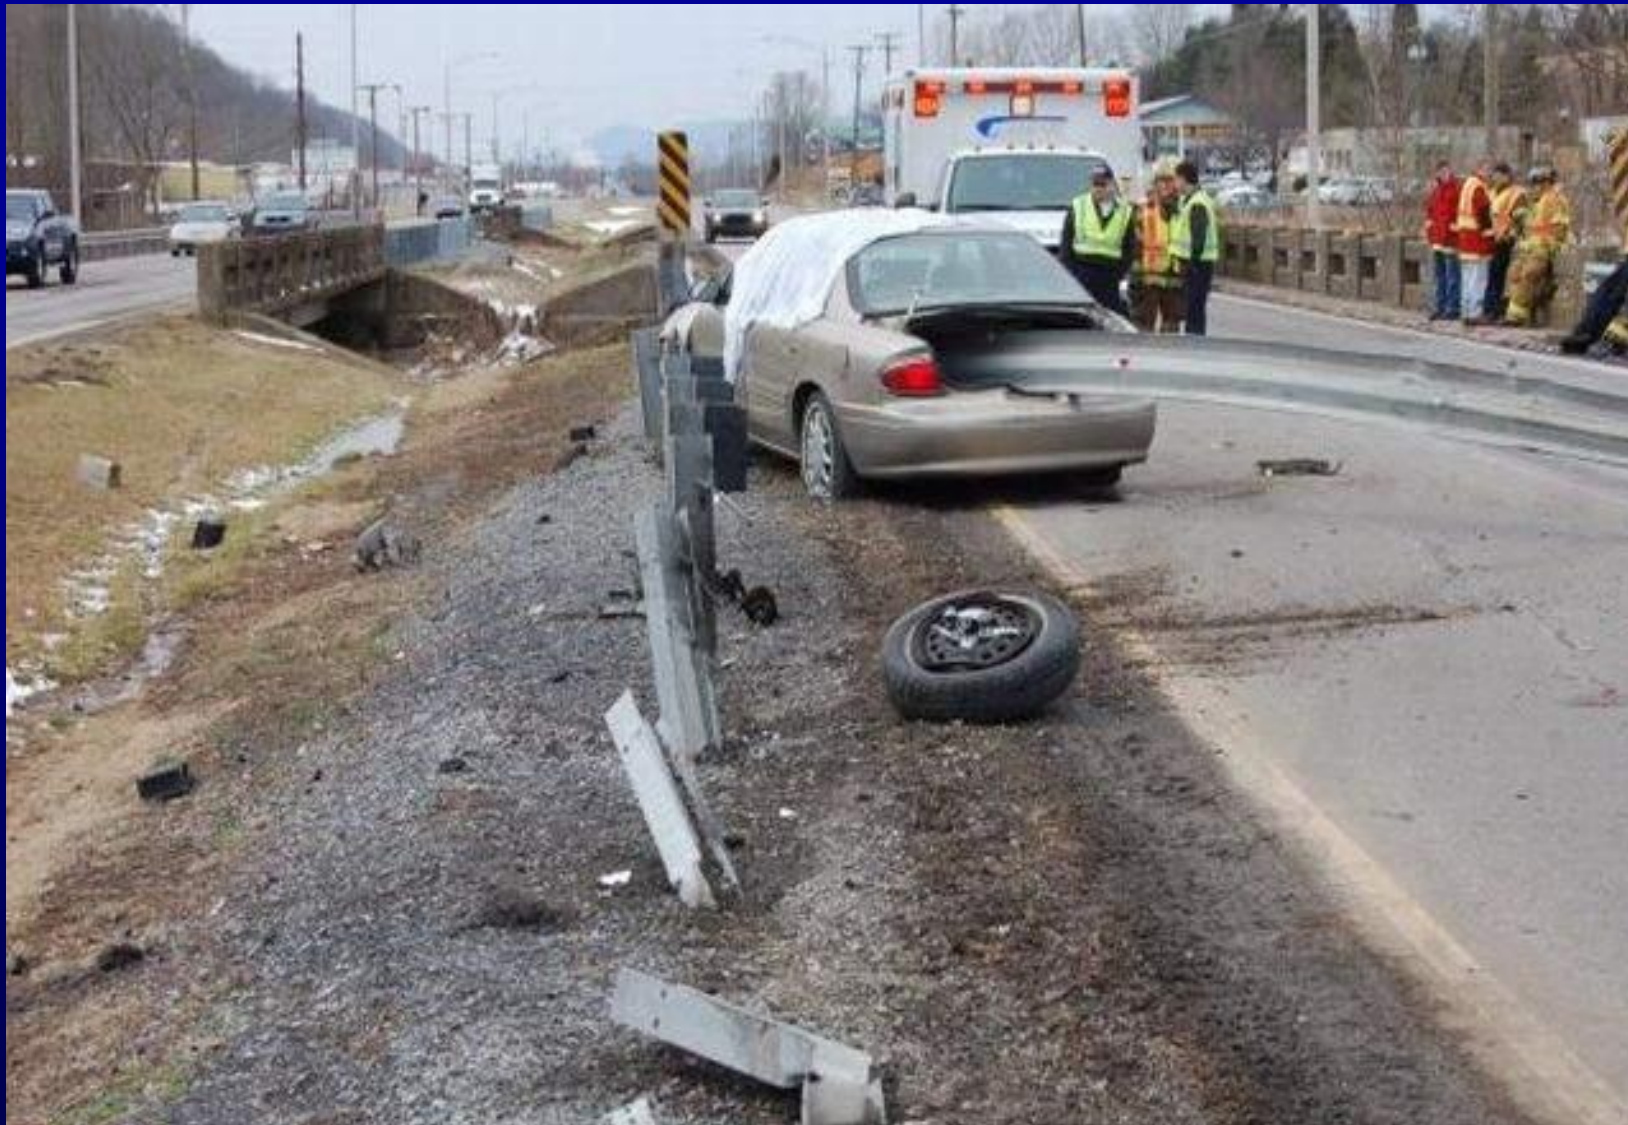
Guardrail End Treatments

Blunt guardrail end treatment

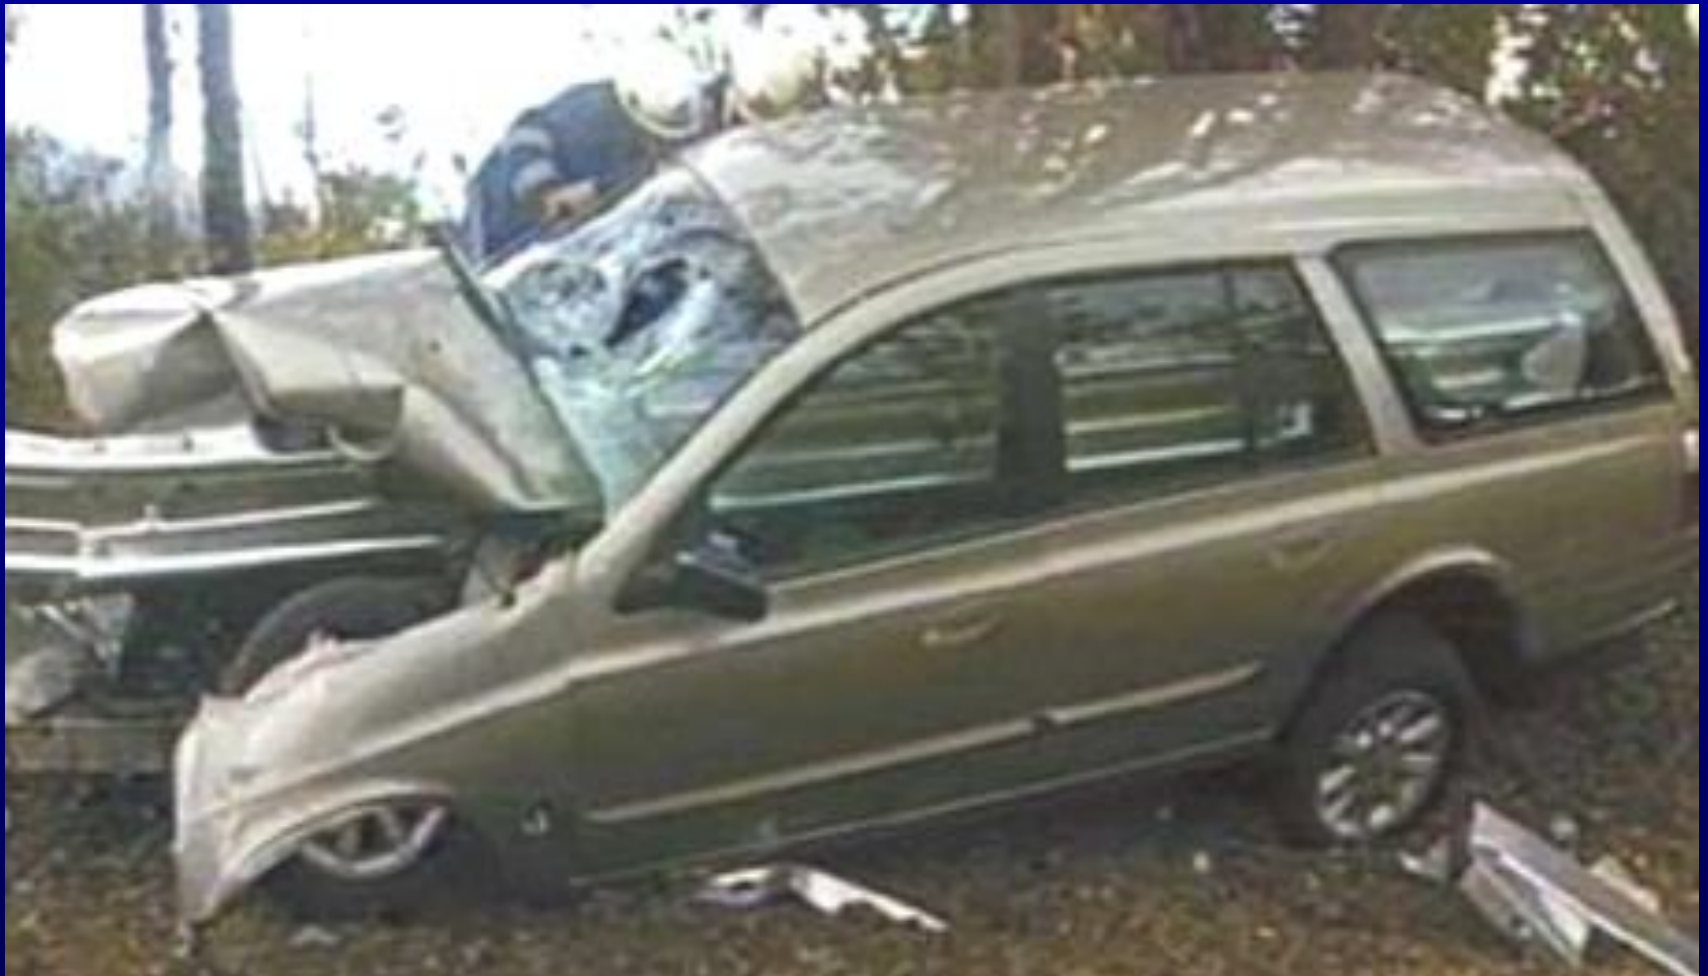
Guardrail End Treatments

Blunt guardrail end treatment

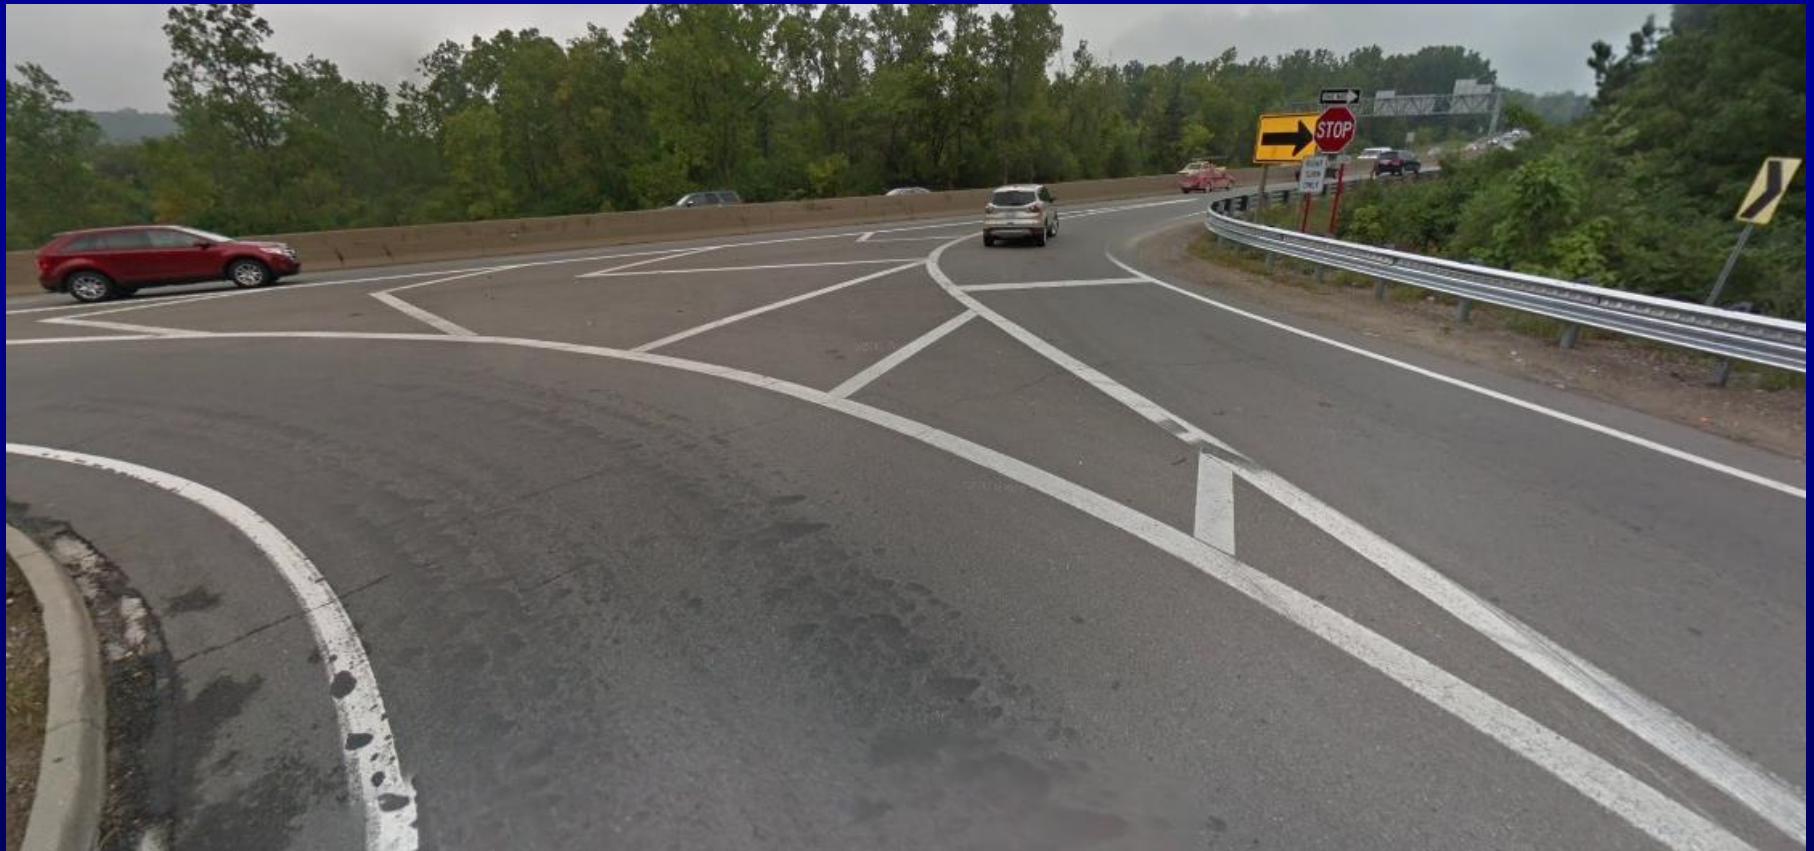
Standardized Roadway Design

Stop sign on entrance ramp to freeway?

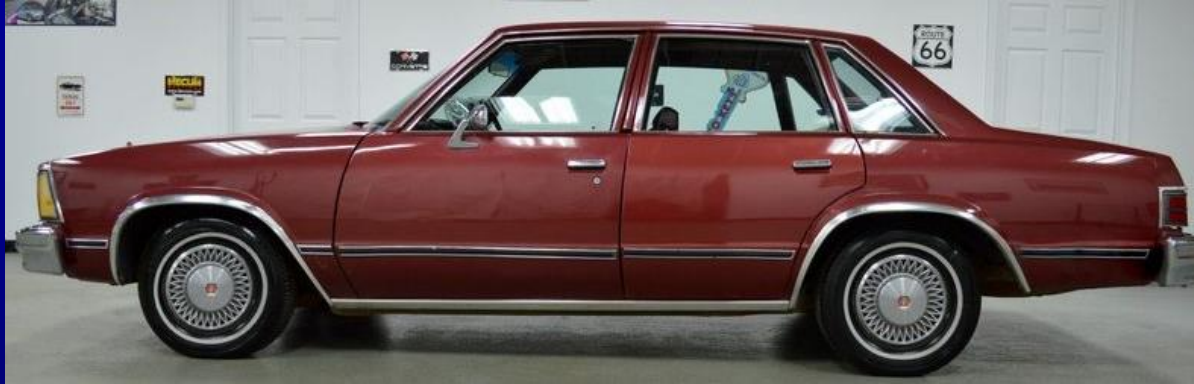
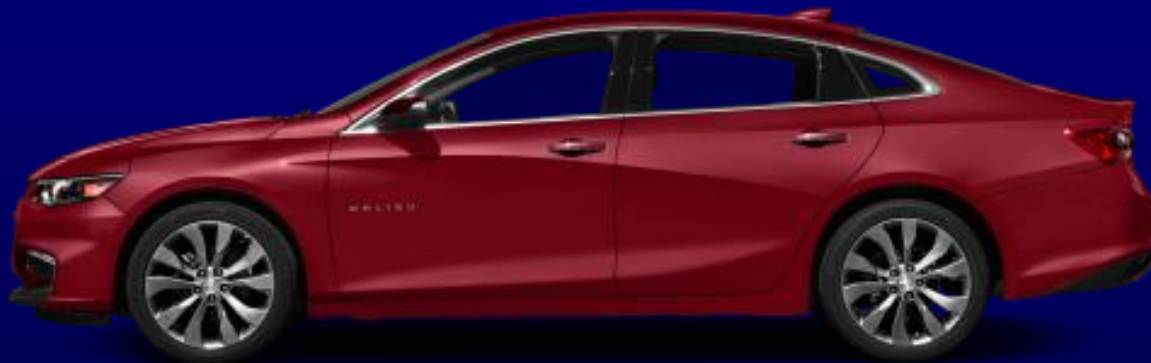
1980 Chevrolet Malibu vs. 2016 Chevrolet Malibu

2016 version is:

2 inches longer

1 inch larger
wheelbase

1 inch wider

70 lbs heavier

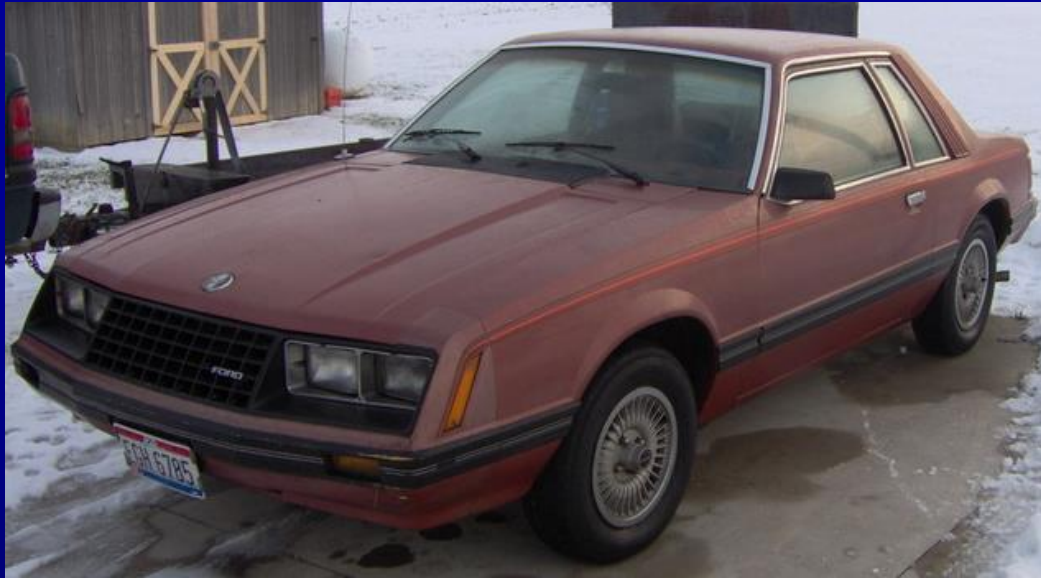
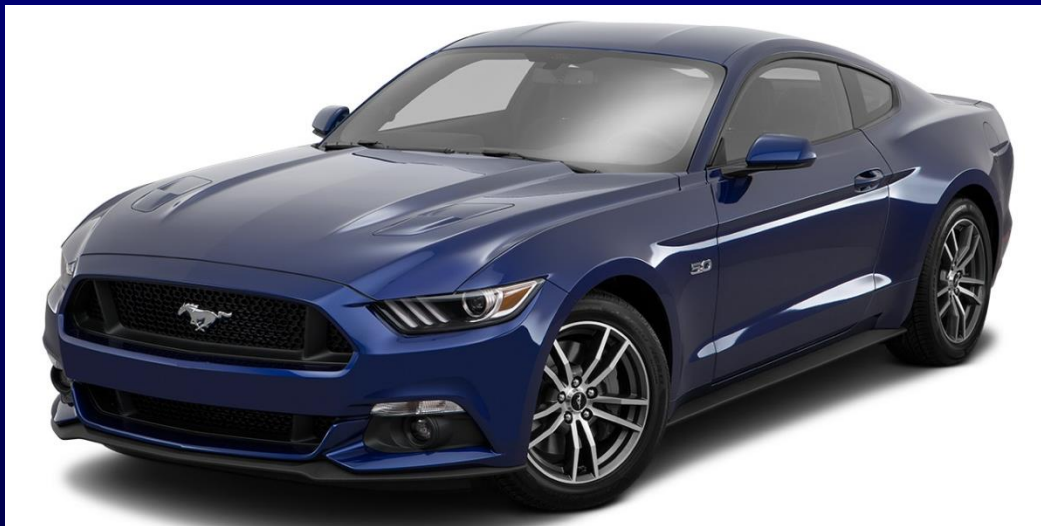
1980 Ford Mustang vs. 2016 Ford Mustang

2016 version is:

9 inches longer

3 inch larger
wheelbase

11 inches wider

950 lbs heavier

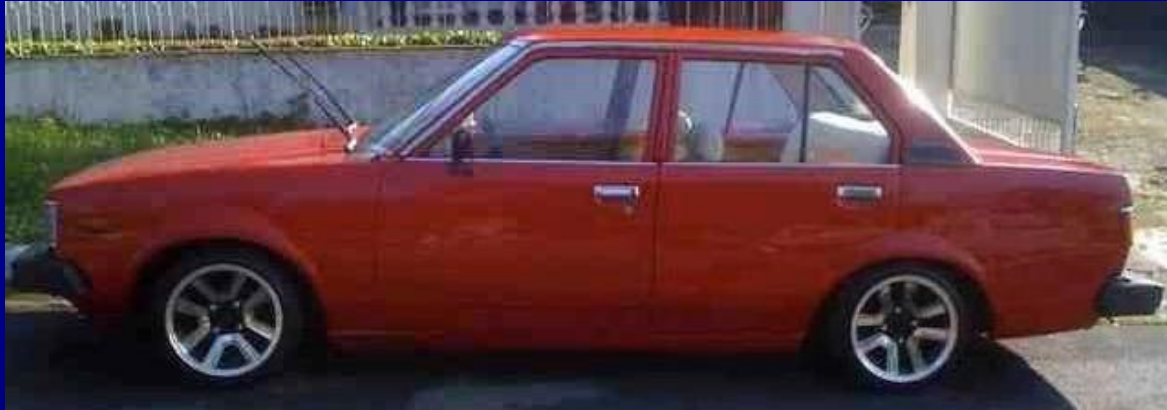
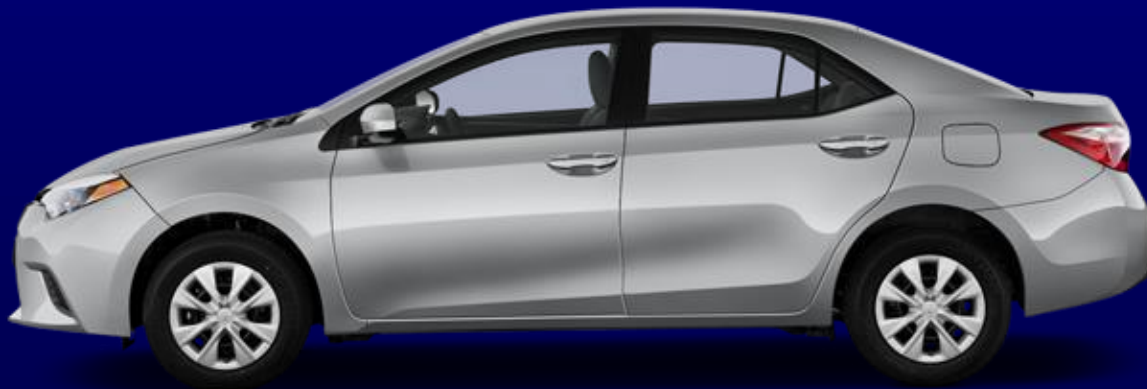
1980 Toyota Corolla vs. 2016 Toyota Corolla

2016 version is:

17 inches longer

12 inch larger
wheelbase

7 inches wider

900 lbs heavier

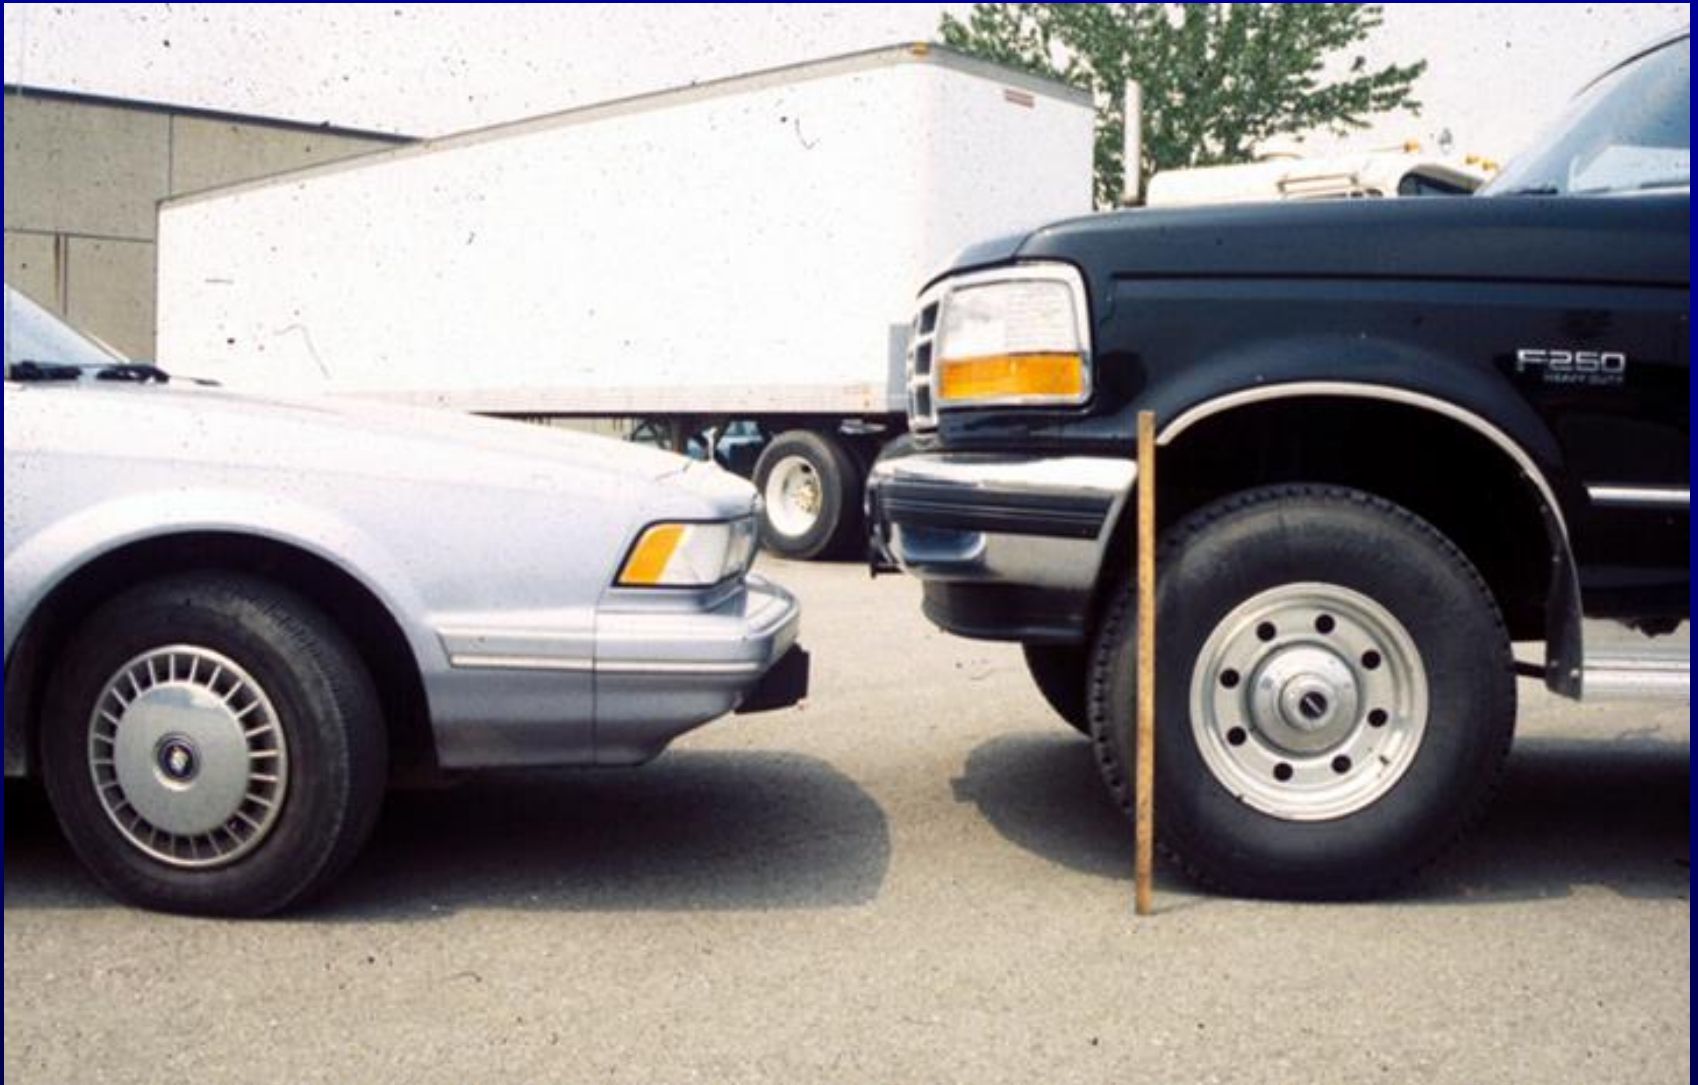
Compatibility Issues

Truck/SUV vs passenger car compatibility in frontal impacts

Most countermeasures involve changes to the trucks/SUVs

Lower frontal structure changed to provide better “catchment” of the struck vehicle

Lowers the risk of “overriding” the struck vehicle

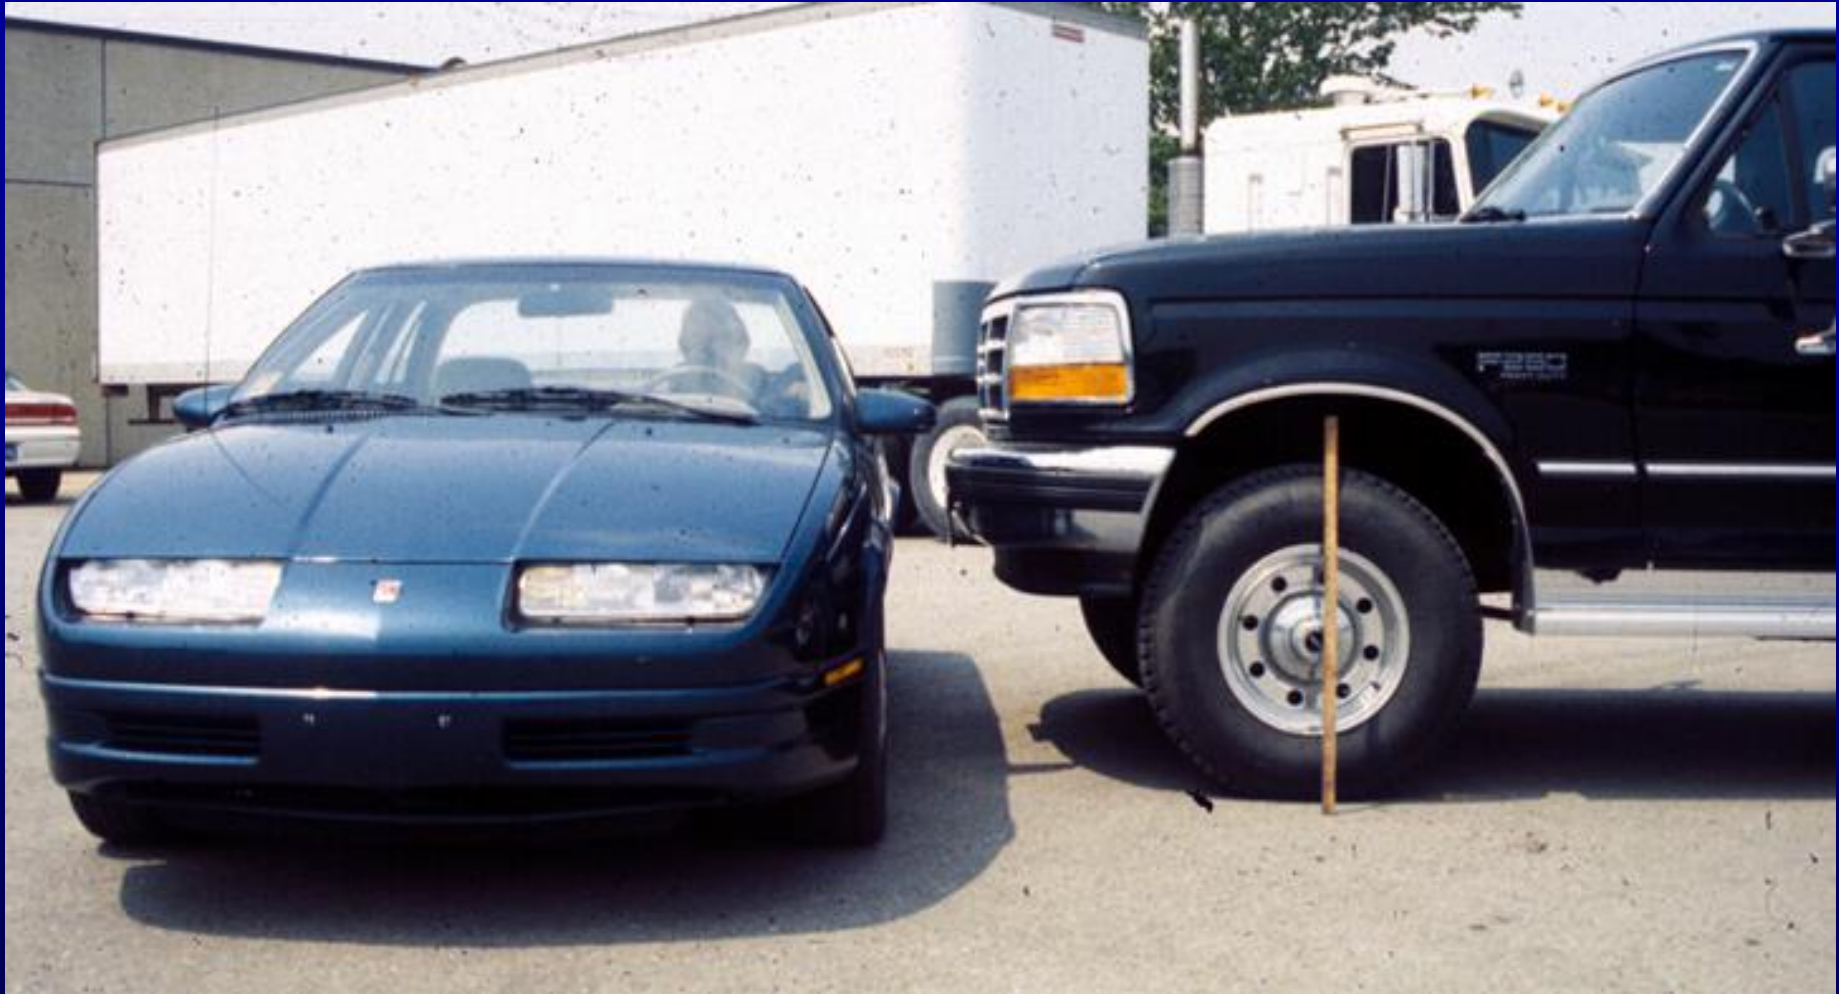
Compatibility Issues

Truck/SUV vs passenger car compatibility in side impacts

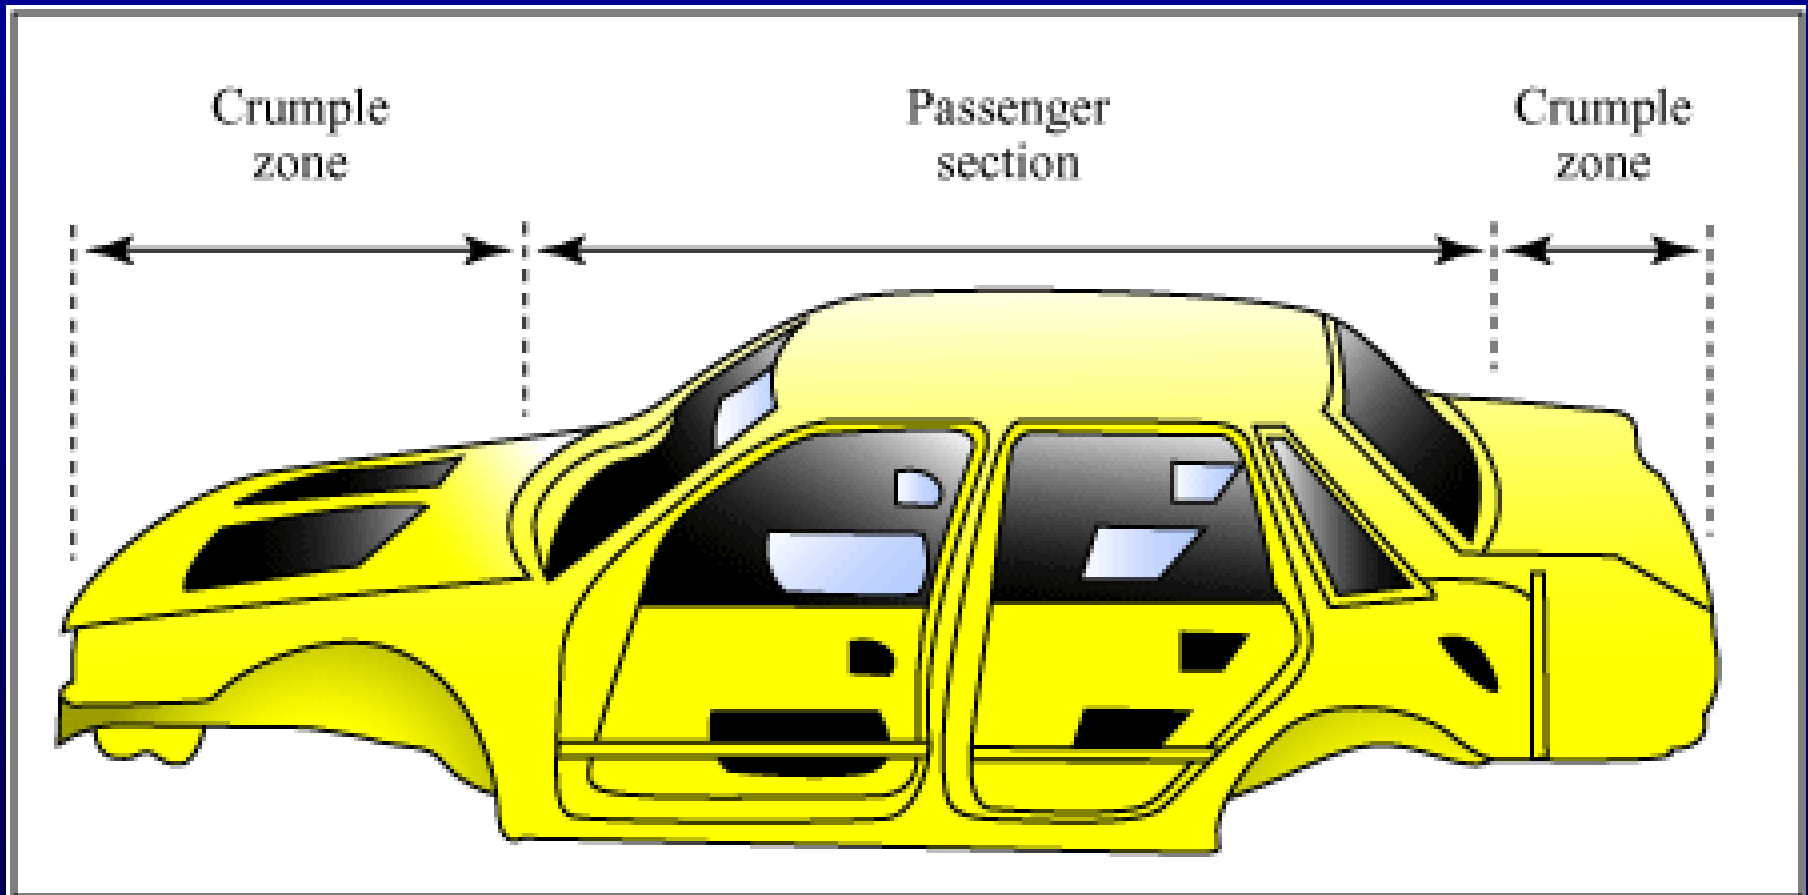
Changes in Safety Technology

The concept of “crumple zones”

Concept of “crumple zones” to dissipate energy

- absorb/dissipate energy by crushing parts of vehicle outside of passenger compartment
- older vehicles were more about reducing damage/repair to vehicle exterior
- save the car, throw away the driver

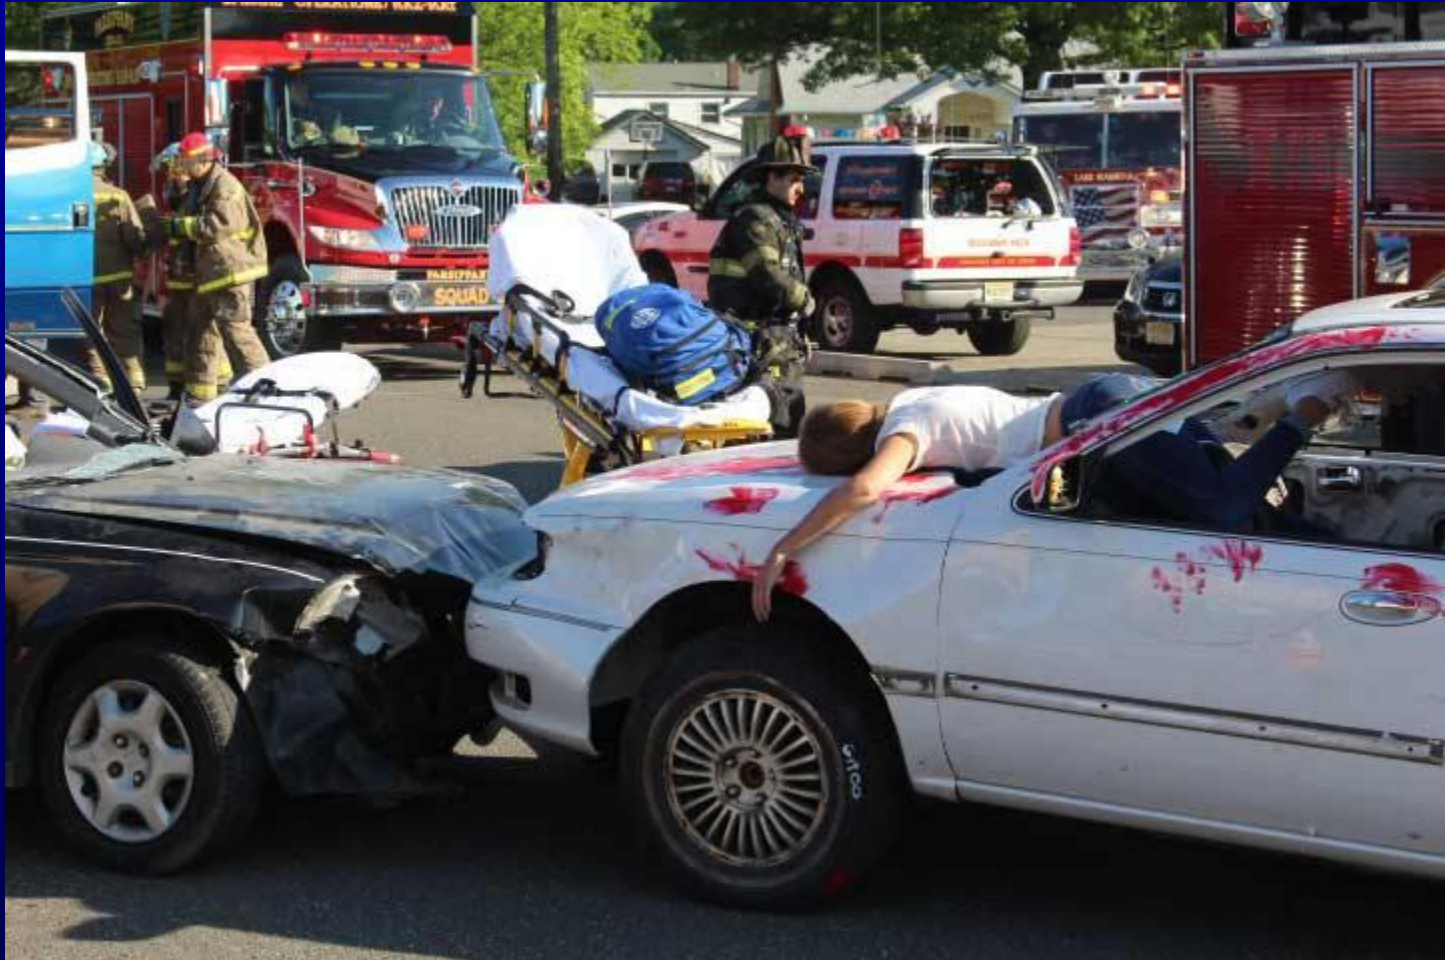
Changes in Safety Technology

Laminated windshields

Laminated glass windshields

- prevent ejections and intrusions from objects

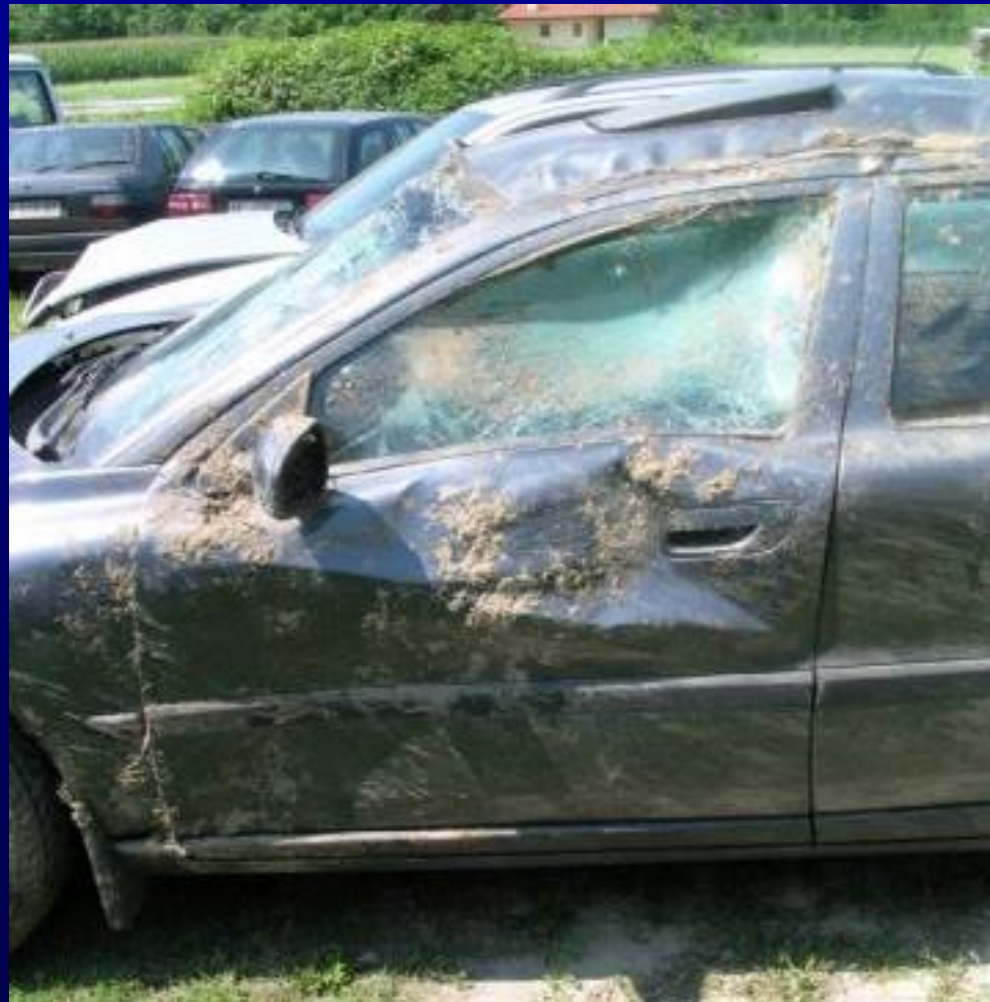
Changes in Safety Technology

Laminated side windows prevent ejection but have higher potential for head/brain injury
