New Cars, Old Patients: New Insights into Crash Biomechanics

**“Innovations in Emergency Care”
William Beaumont Hospital
March 12, 2018**

**Joel B. MacWilliams, B.A.
International Center for Automotive Medicine
University of Michigan**

Subtitle
**What 38 Years of Crash
Investigation Has Taught Me**

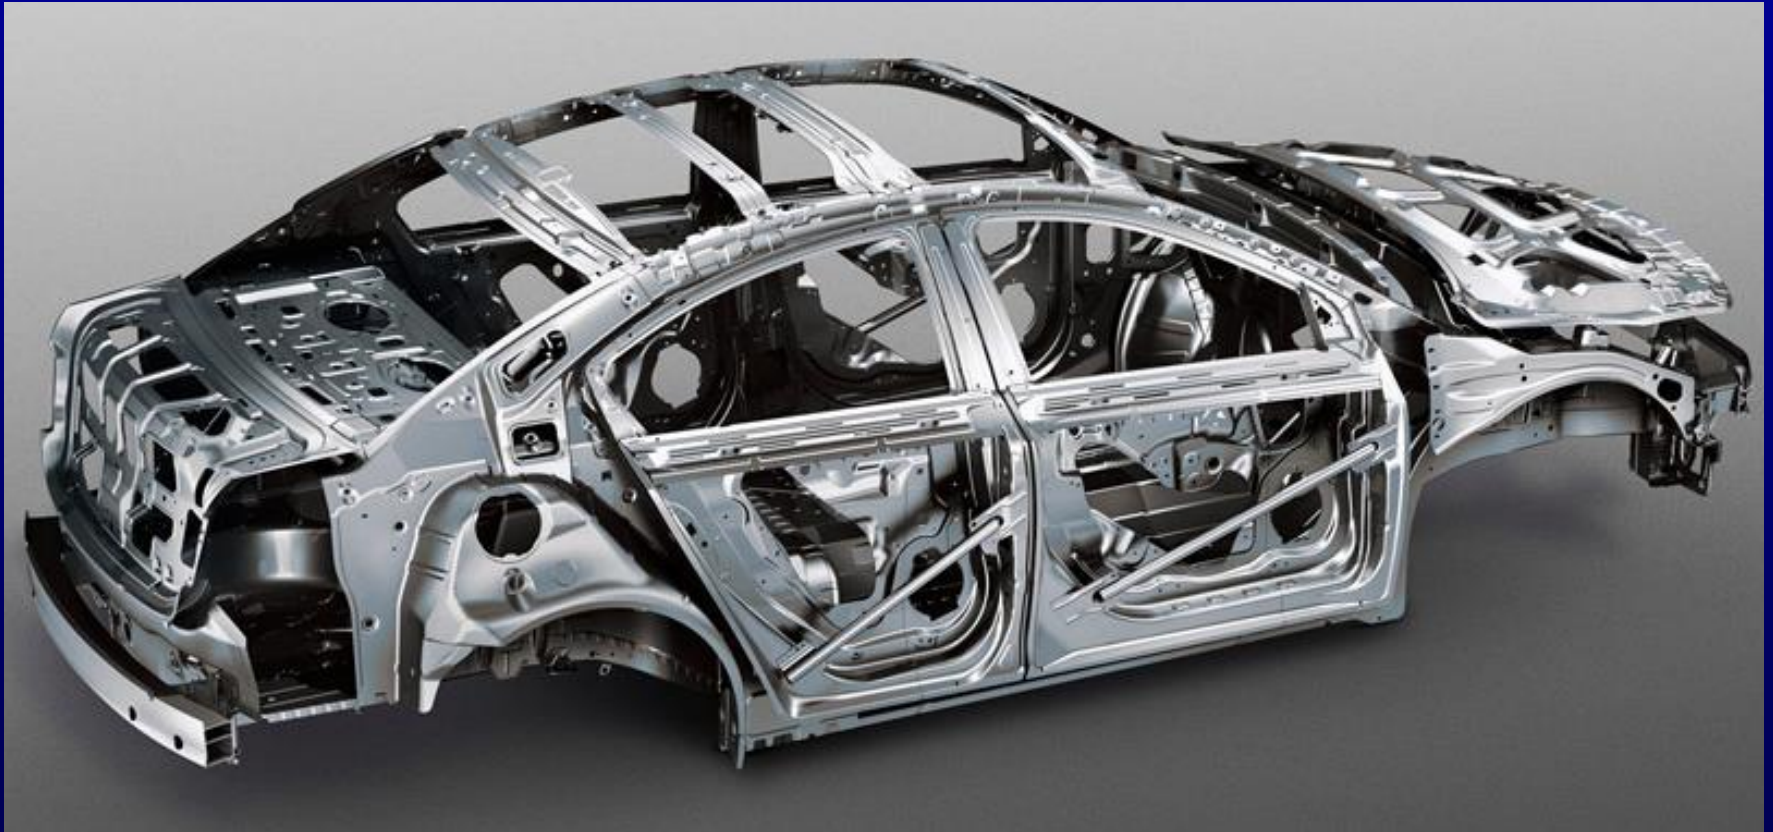
Changes in Safety Technology

Side impact beams in doors

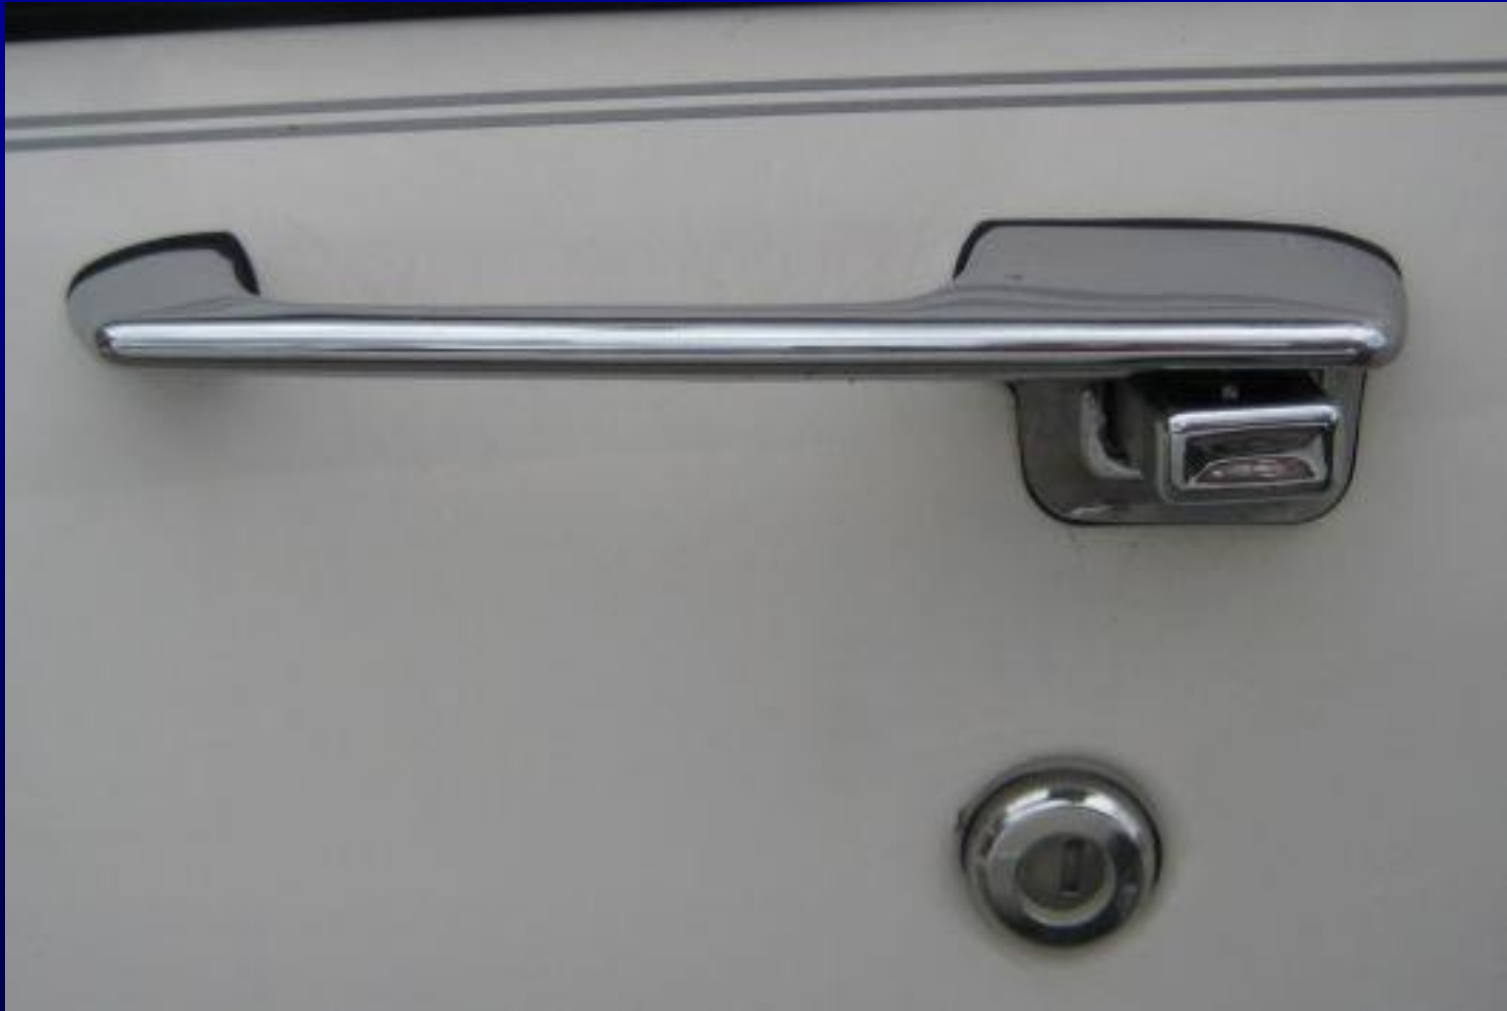
Changes in Safety Technology

Door latch design

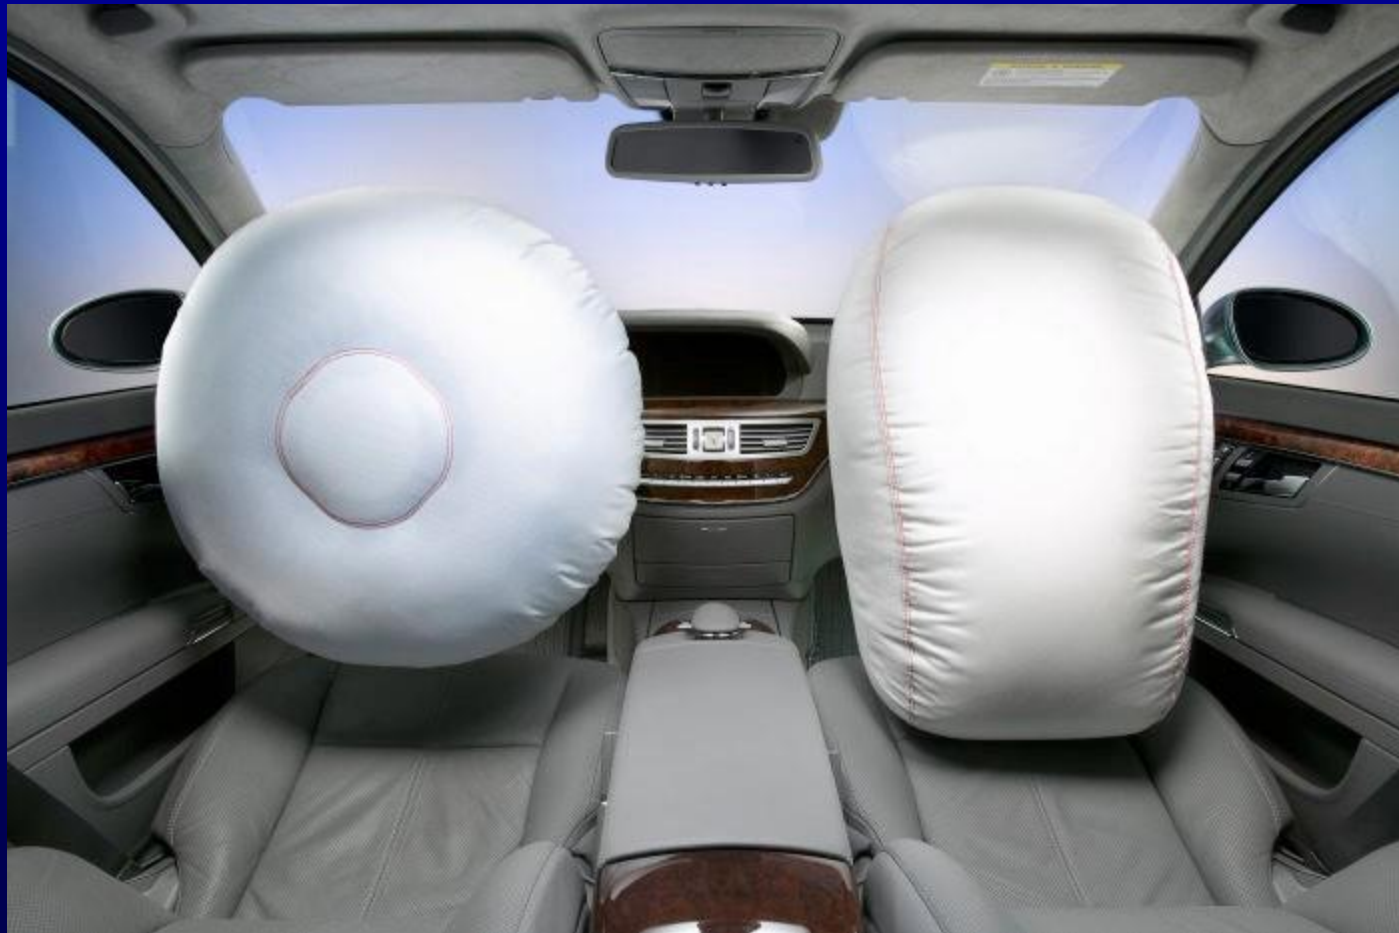
Changes in Safety Technology

Introduction of “airbags” as standard equipment (1988)

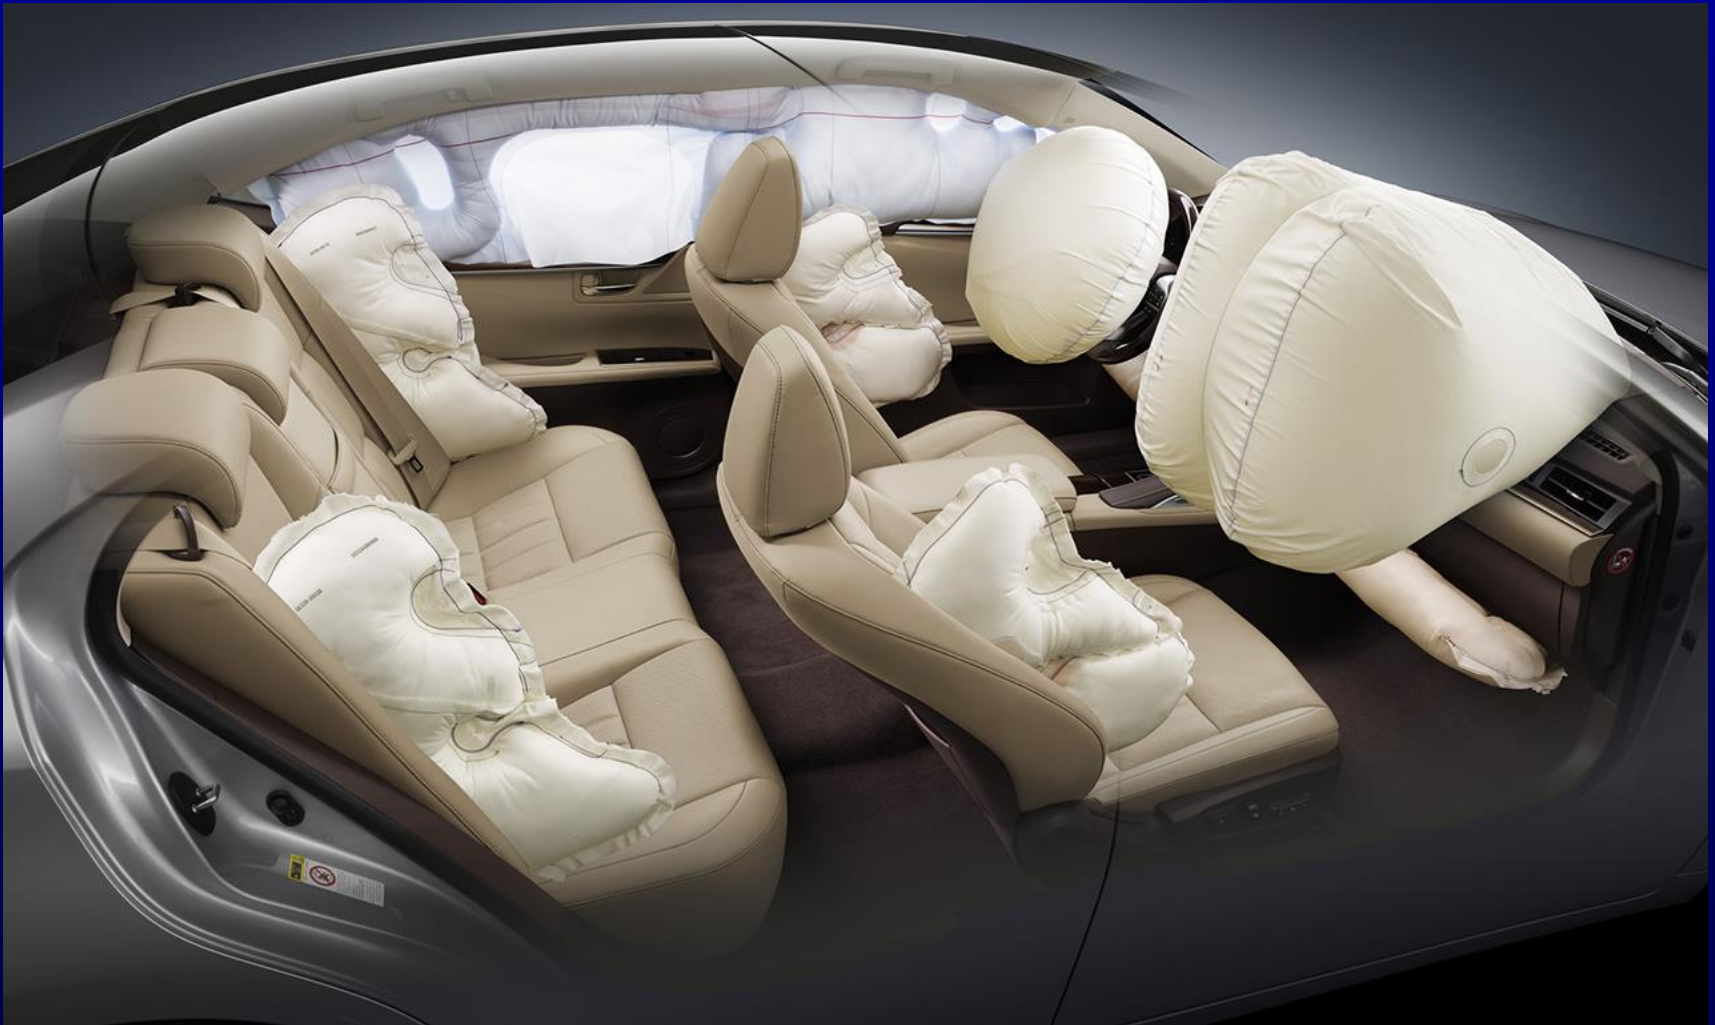
Changes in Safety Technology

.....and their continued development

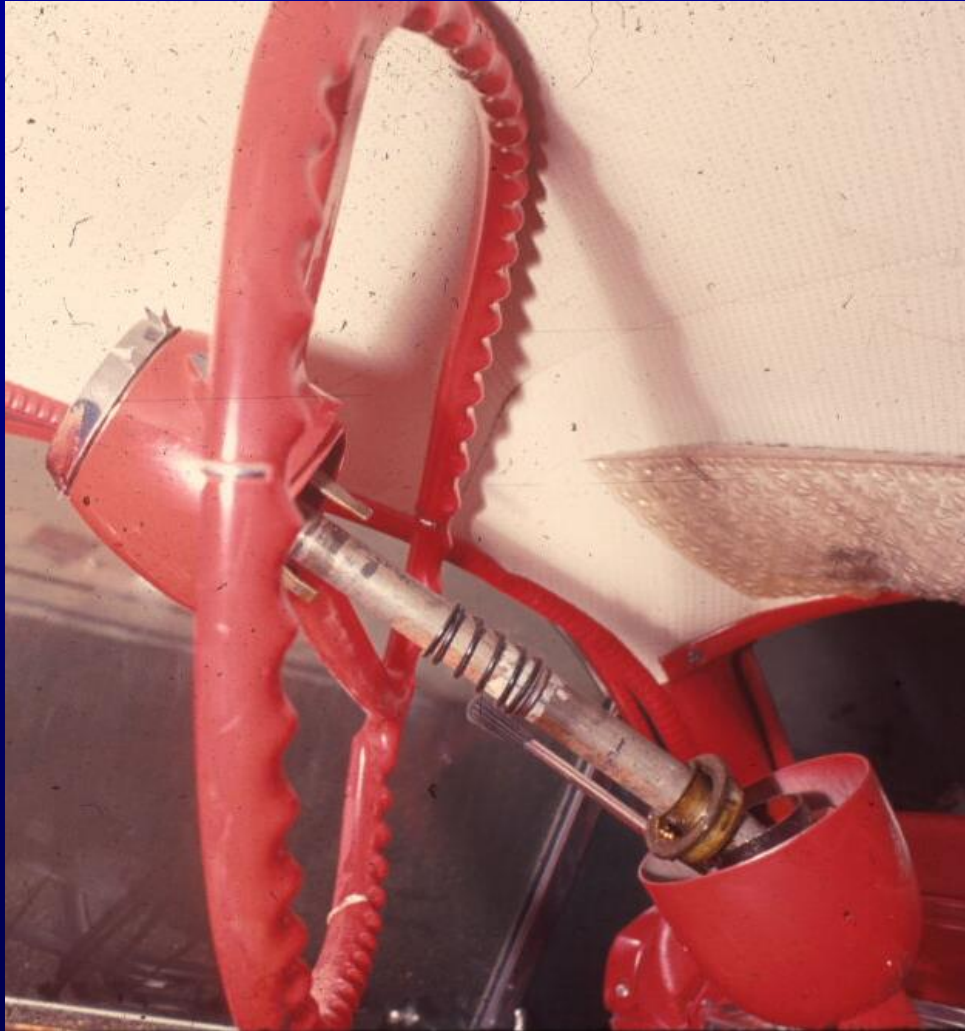
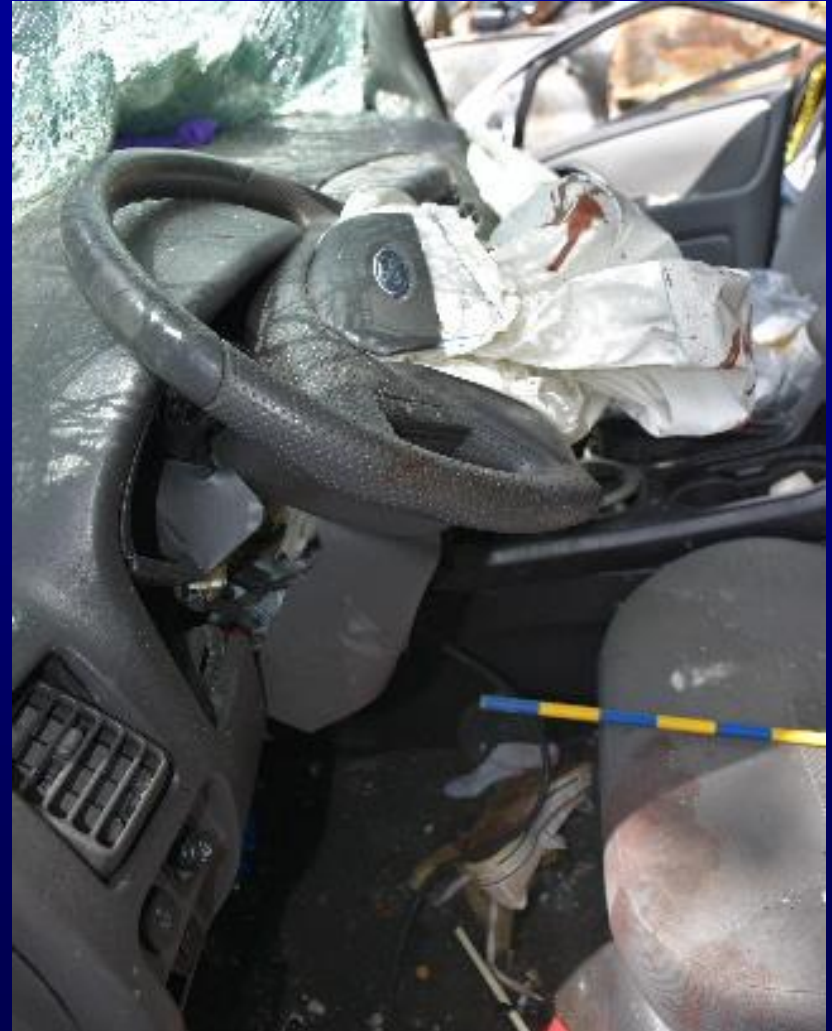
Changes in Safety Technology

Collapsible Steering Columns

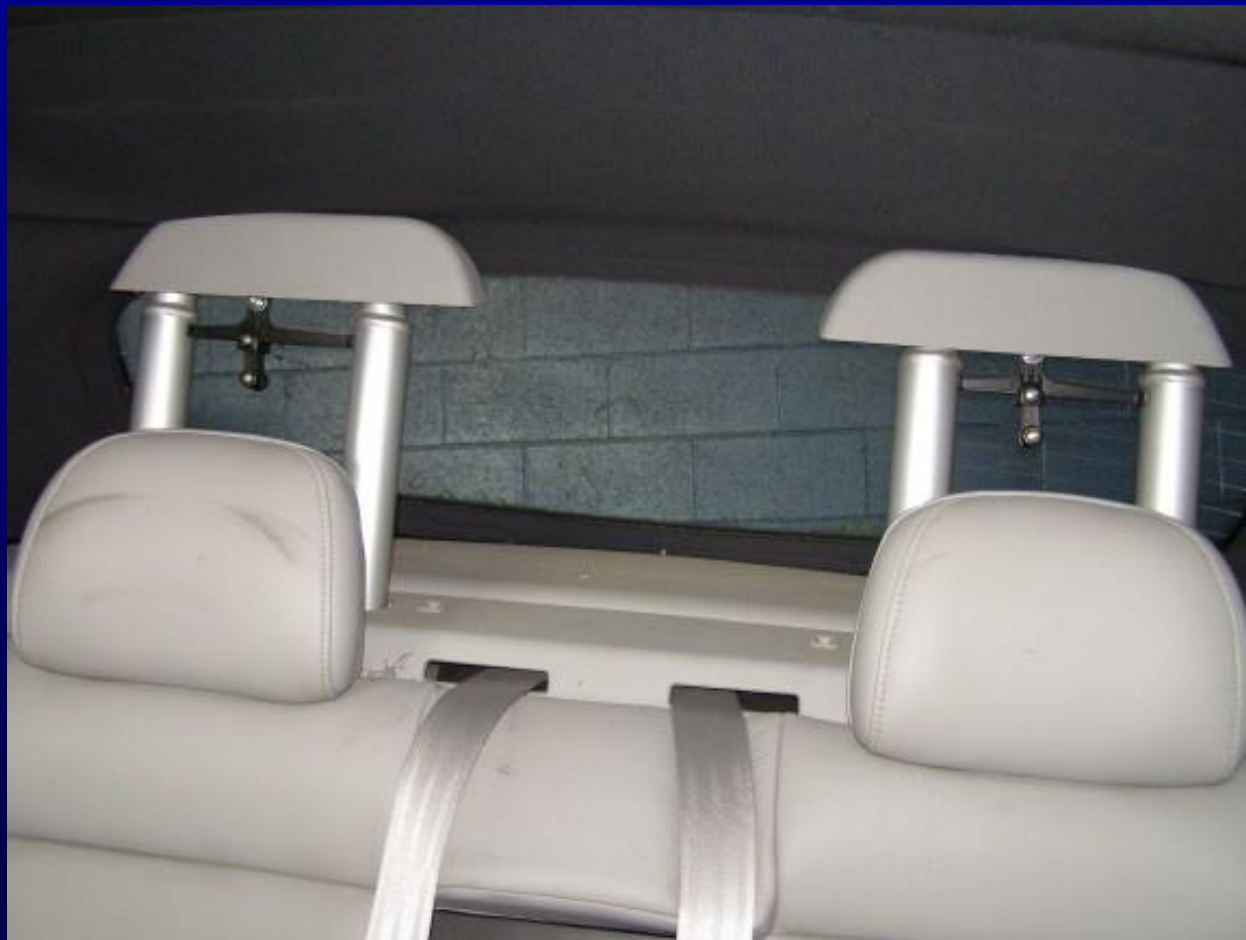
Changes in Safety Technology

Deployable head restraints to mitigate roof crush in rollovers

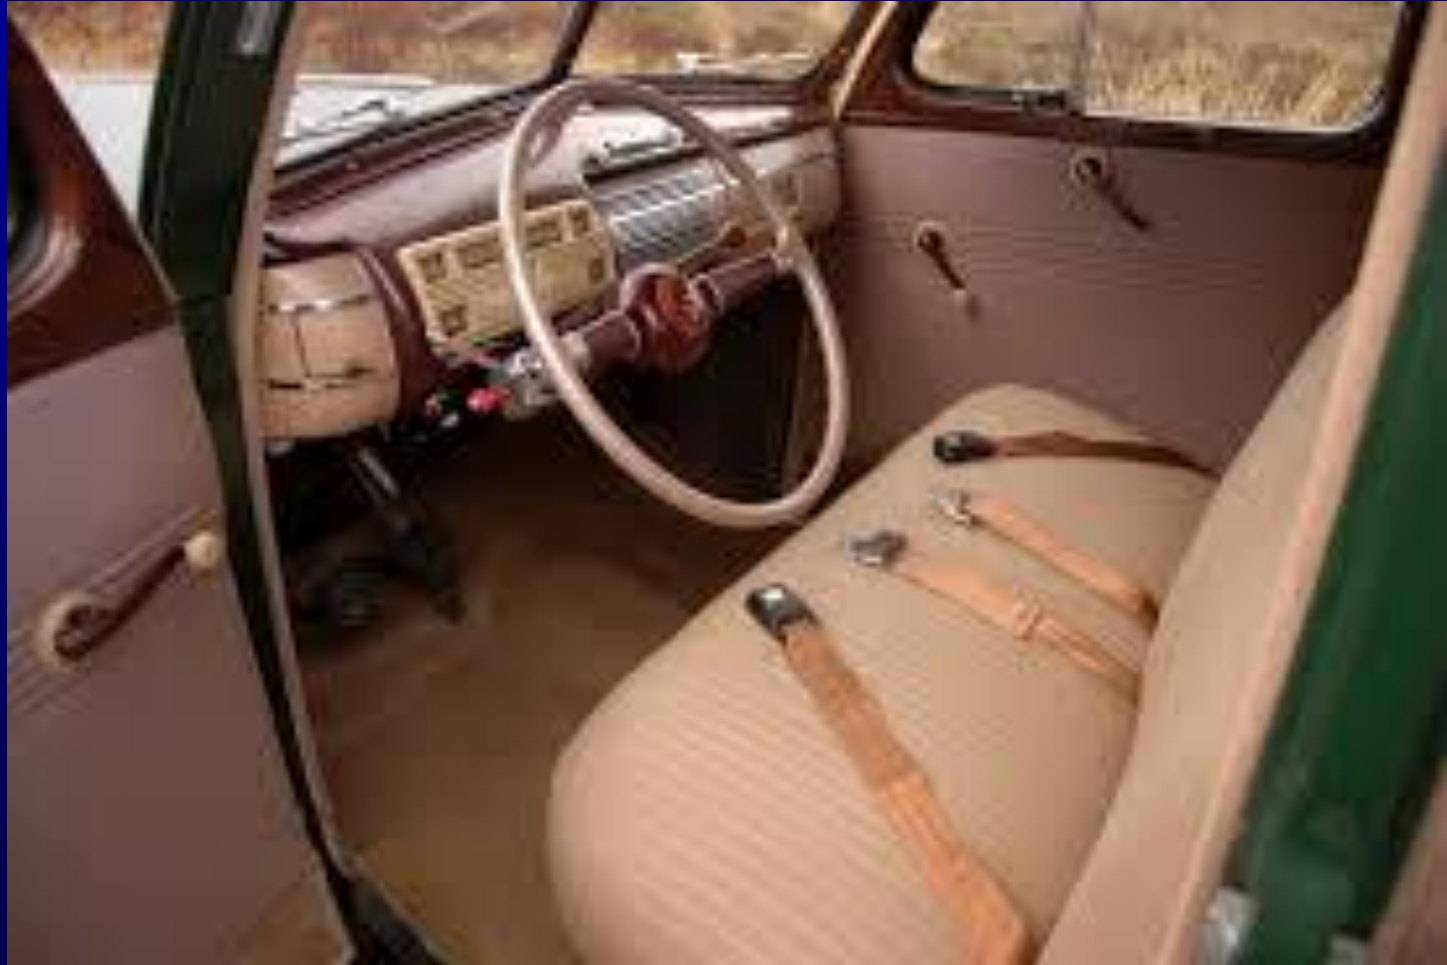
Changes in Safety Technology

“Stiff” seat belts from the 60’s

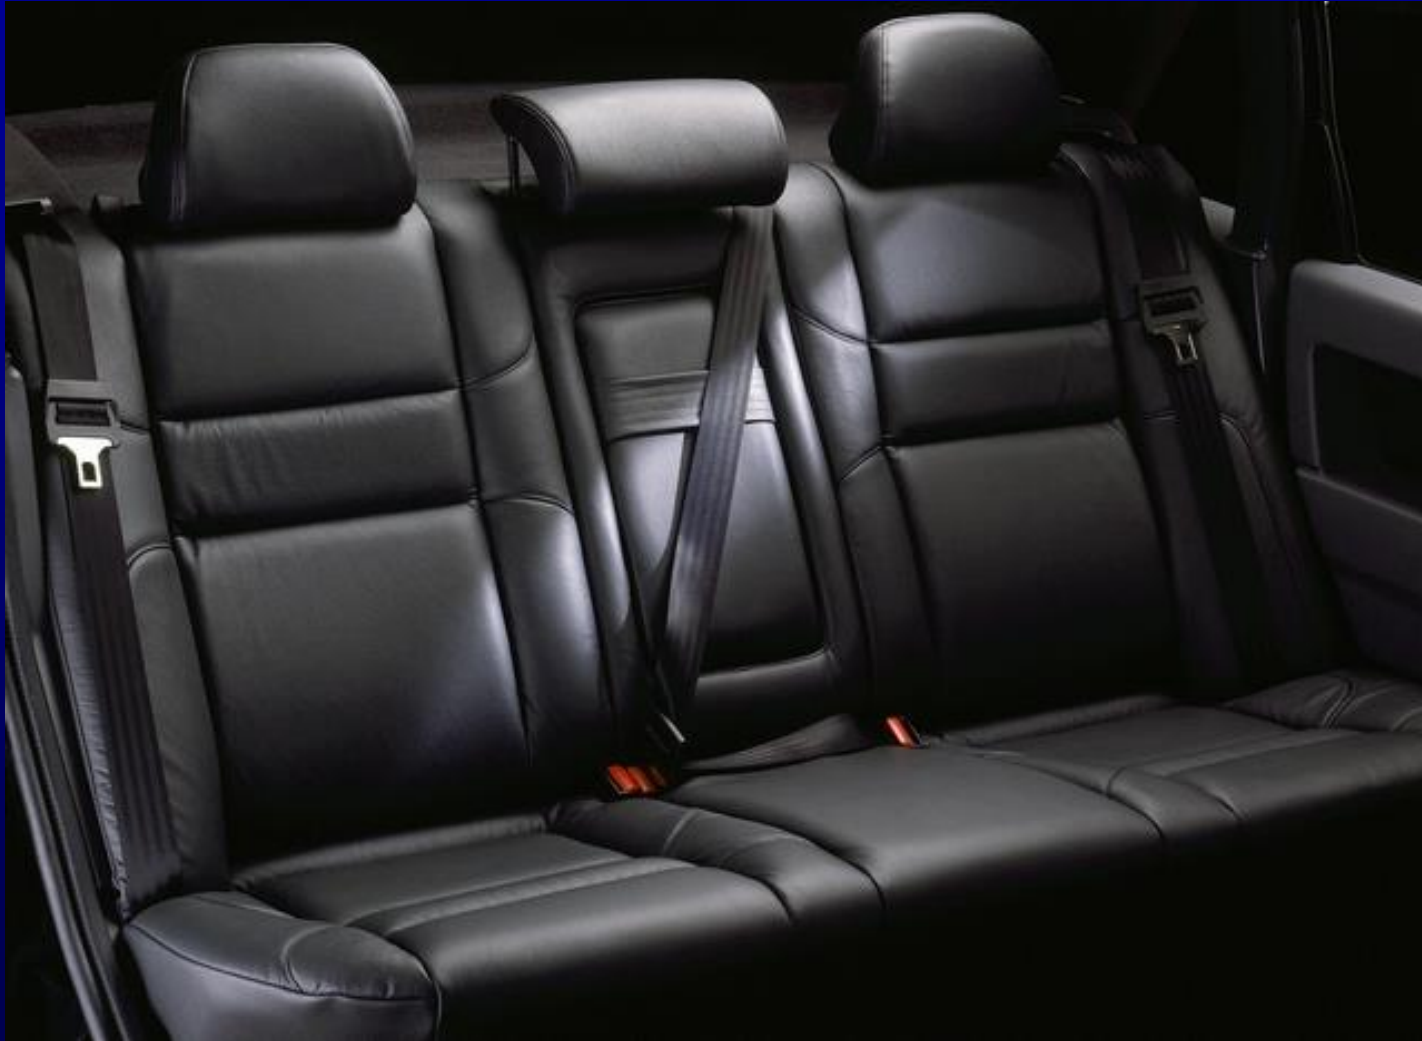
Changes in Safety Technology

“Modern” seat belts

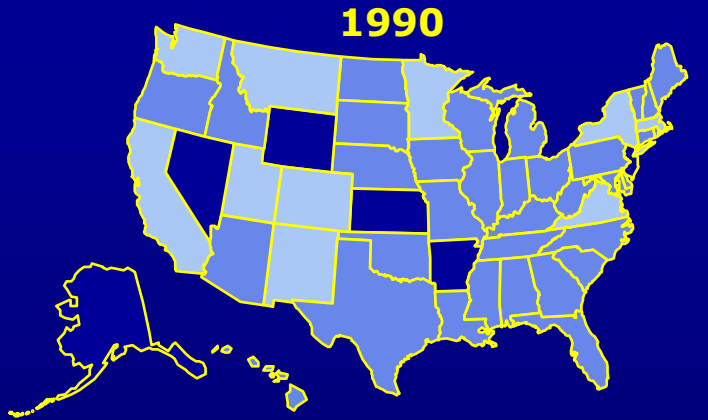
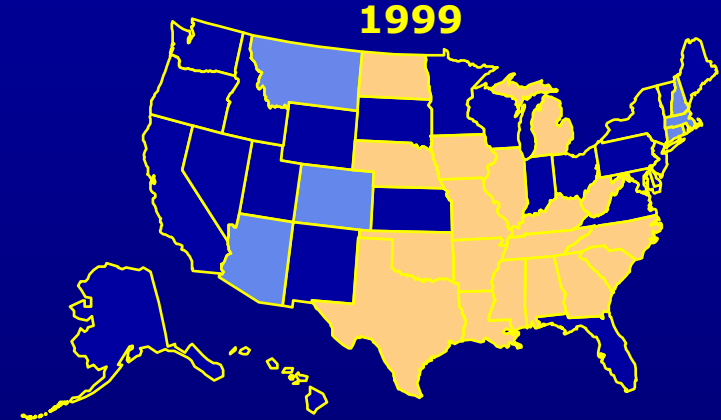
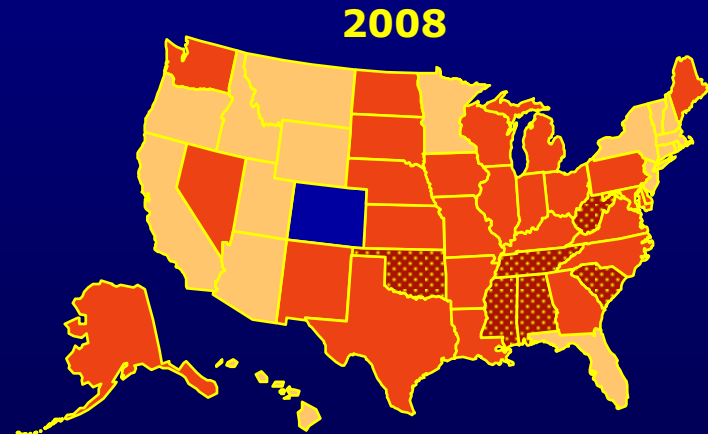
Obesity Trends* Among U.S. Adults

BRFSS, 1990, 1999, 2008, 2016

(*BMI ≥30, or about 30 lbs. overweight for 5'4" person)

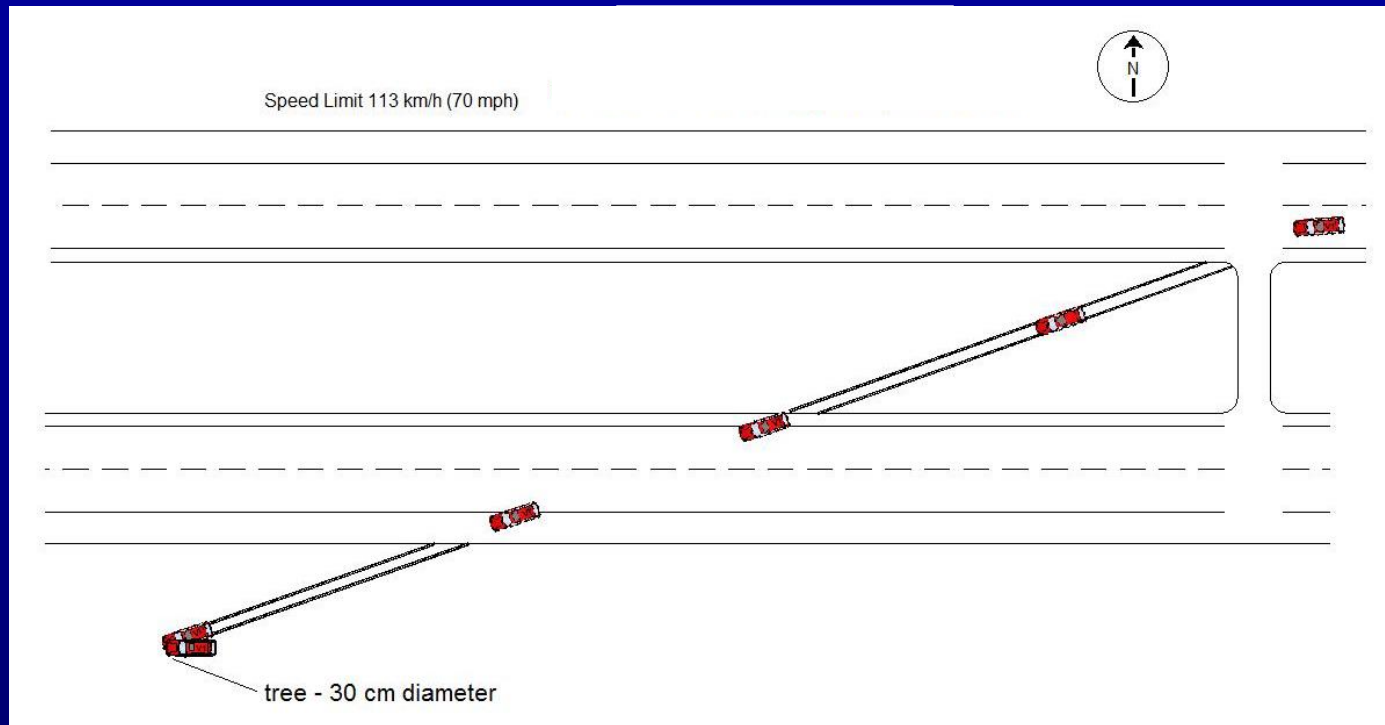
Crash Scenario

- **2015 Chevrolet Equinox vs. tree**
- **Dark, clear, dry asphalt roadway**
- **Driver of V1 reportedly fell asleep while driving**
- **V1 departs left side of road, crosses median & EB lanes & departs freeway**
- **V1 strikes a tree (30 cm diameter) with front end of V1**
- **DR & RF passenger are case occupants of V1**

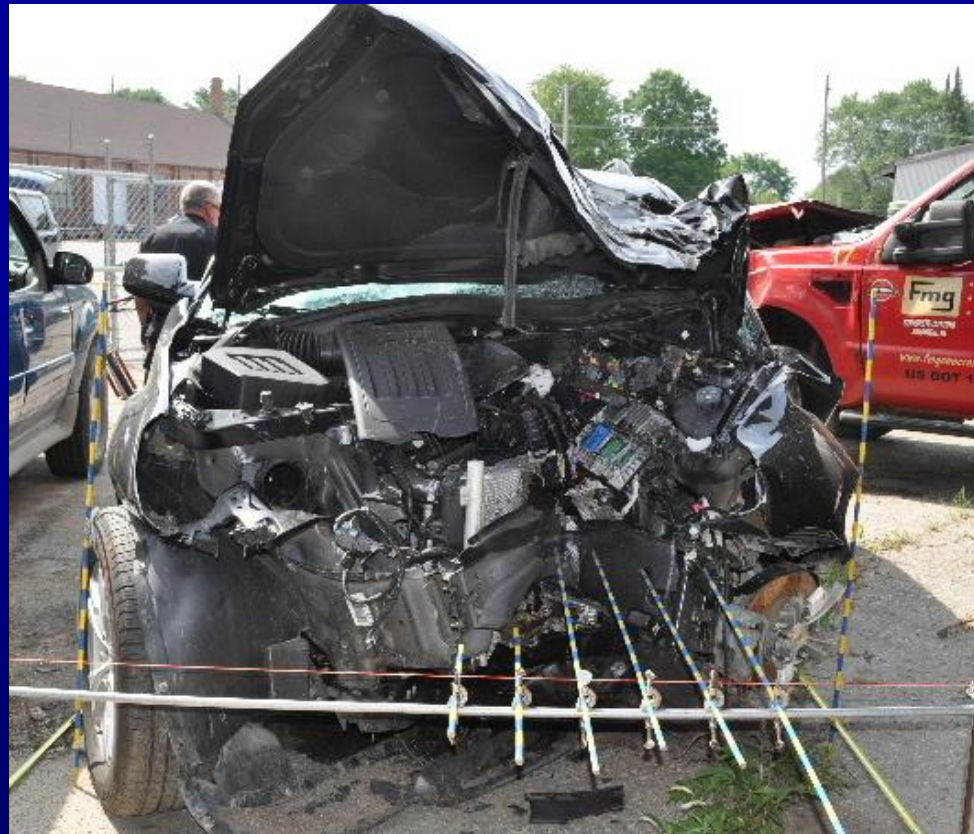
Case Vehicle – 2015 Chevrolet Equinox

CDC :	12-FYEN-5	Mass: 1706 kg
Direct damage length:	33 cm	
Max Crush:	98 cm	
PDOF:	0 degrees	
Severity:	50 ΔV mph	EDR: -60 ΔV mph
	- 50 longitudinal	
	0 lateral

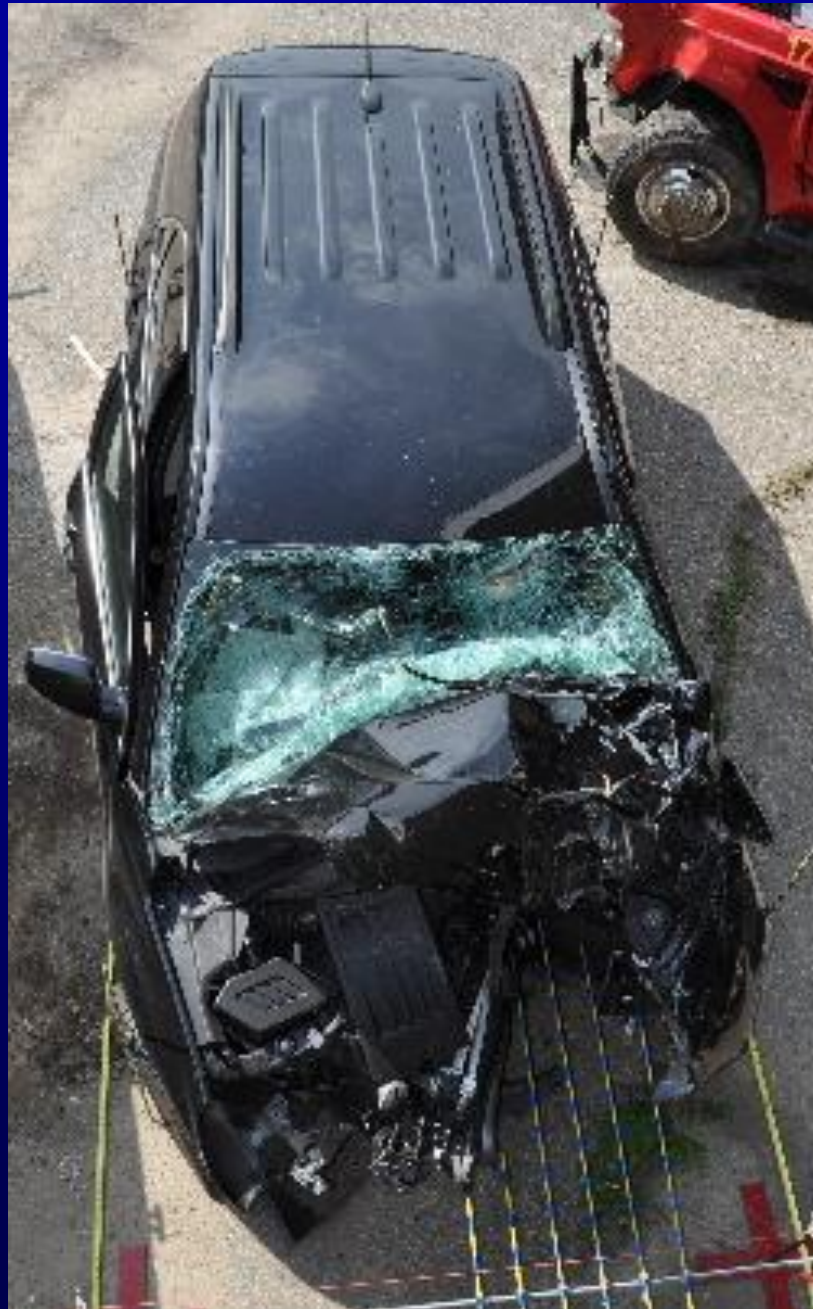
Case Vehicle – 2015 Chevrolet Equinox

Case Occupant

- driver
- 21-year-old male
- 5 ft 7 in (170 cm)
- 158 lb (72 kg)
- 3-point manual belt not used
- SW & curtain airbags deployed
- ISS – 27
- LOS – 18 days
